Water-tightness Airborne Detection Implementation

D6.1 - Operational and surveillance demonstrations on water supply and irrigation mains in Portugal - update

Authors: ONERA, GG, AM, SGI, EDIA

31st May, 2020

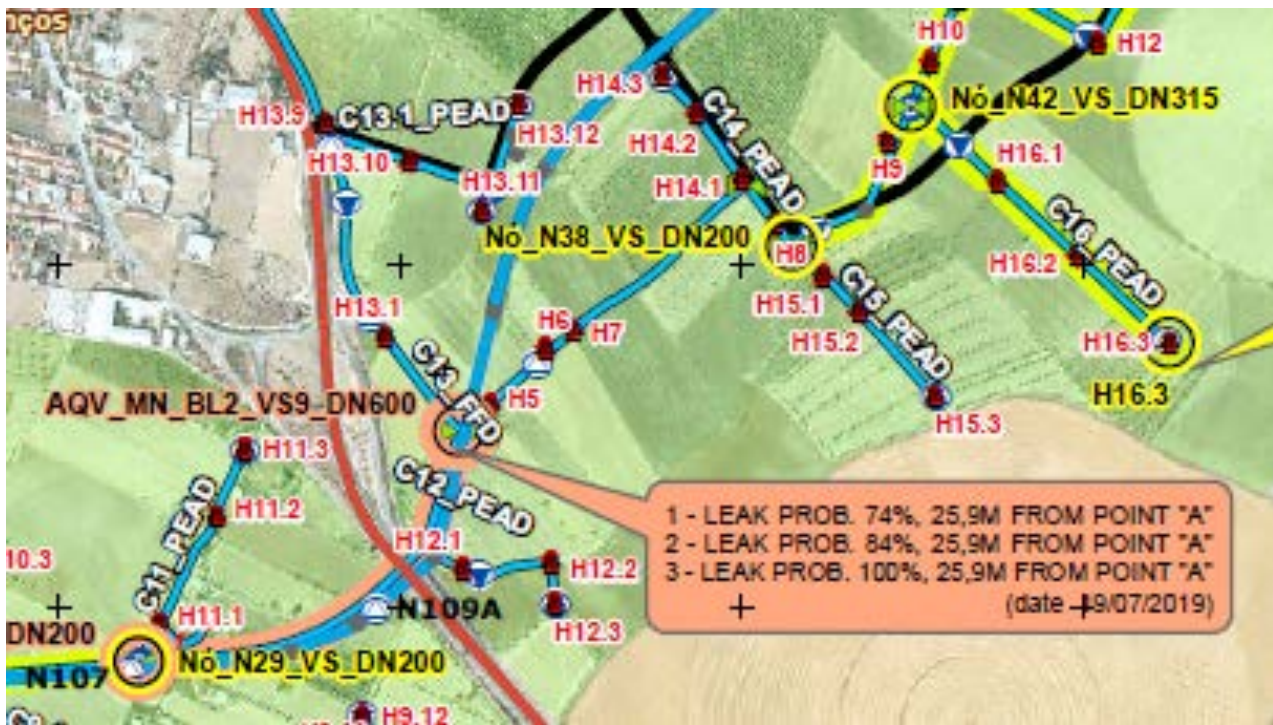
Figure 21 : positive results on block 2, Monte Novo

One positive result was registered, on Hydrant H16.3, which was identified as a small superficial leak (in a tube on the hydrant, and not in an underground pipe).

Also, 3 other correlations signalled and confirmed a leak in the same location, even reaching a 100% probability of leakage. This leak candidate is located 25.9 meters from GIS node reference "Nó_N31_VS9", which is an air valve on water pipe (see Figure 21 below).

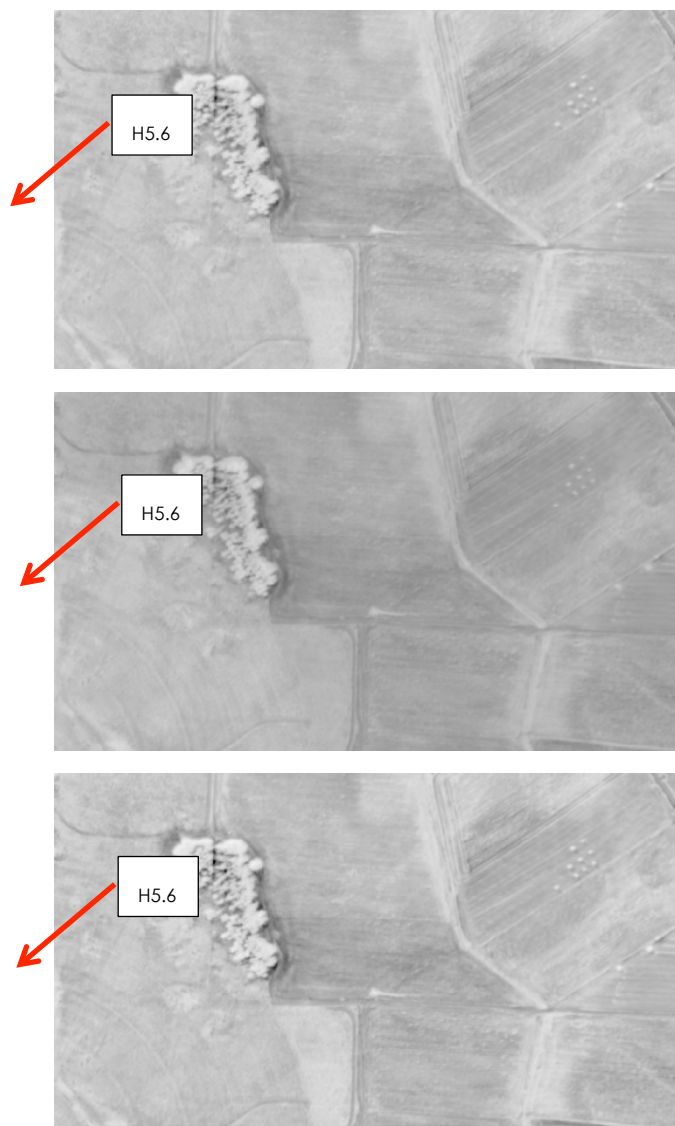
Figure 66 : Moisture maps (close up in the area of the artificial leak H5.6) as obtained according to Processing 1, 2 and 3 (from top to bottom). The leak H5.6 is clearly seen.

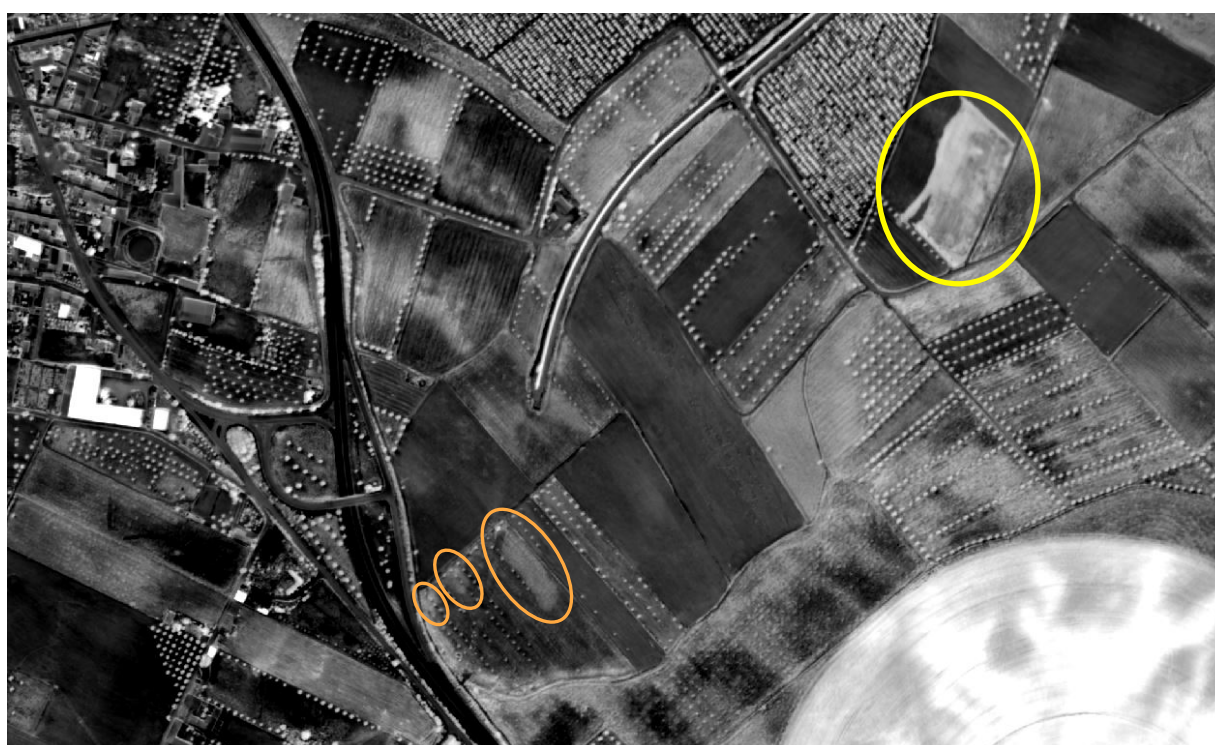
Figure 68 : Excerpt of the moisture map east of the village Sao Manços. Orange ellipses, close to hydrant H5, indicate areas with excess moisture that have been interpreted to be due to runoff from an uphill irrigated field (see the next figure for more details). The yellow ellipse indicates an irrigated corn field.

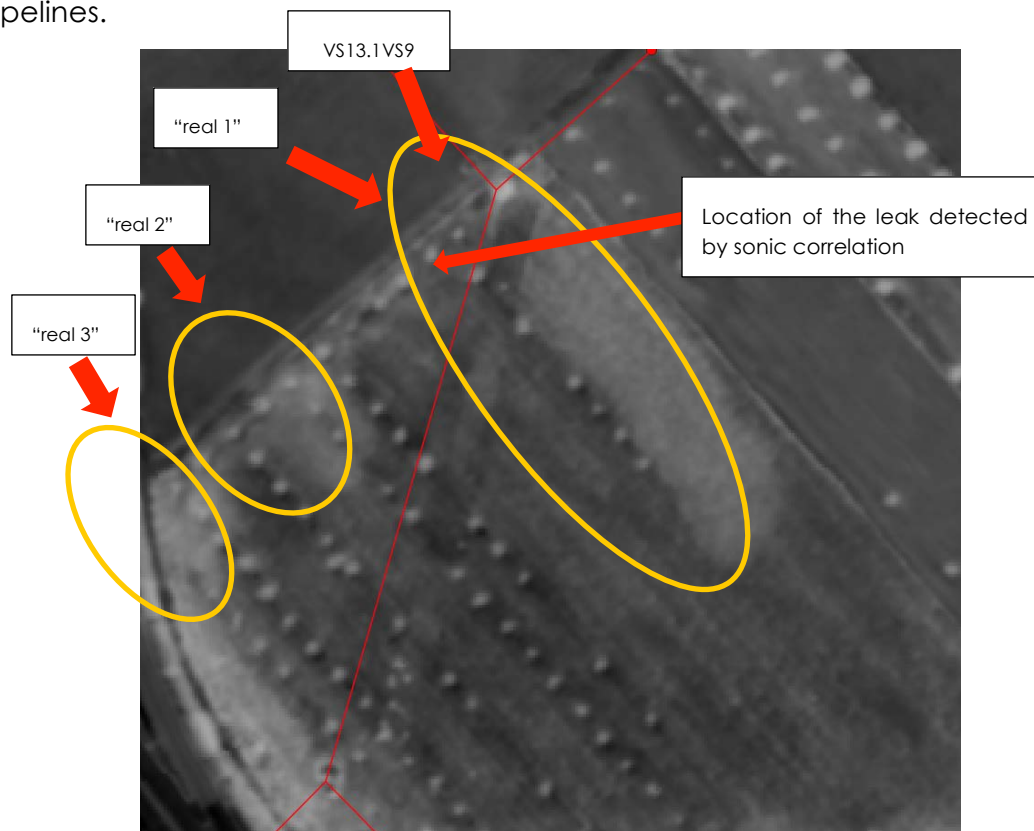
Figure 69 : Close up of the moisture map near air valve VS13.1VS9. Orange ellipses indicate areas with excess moisture that have been interpreted to be due to runoff from the irrigated field uphill in the north-west. A water leak was detected by SGI (sonic correlation) 25.9m south of VS13.1VS9 which roughly corresponds to the first olive tree along the pipe. Since the slope is downhill from north-west to south-east, the bright area (high WI) called ""real1"" could be interpreted as a leak from VS13.1VS9; it should thus be classified as ""false positive"". On the other side, since the bright areas called ""real2"" and ""real3"" are uphill from the pipe, they should be classified as ""true negative"".

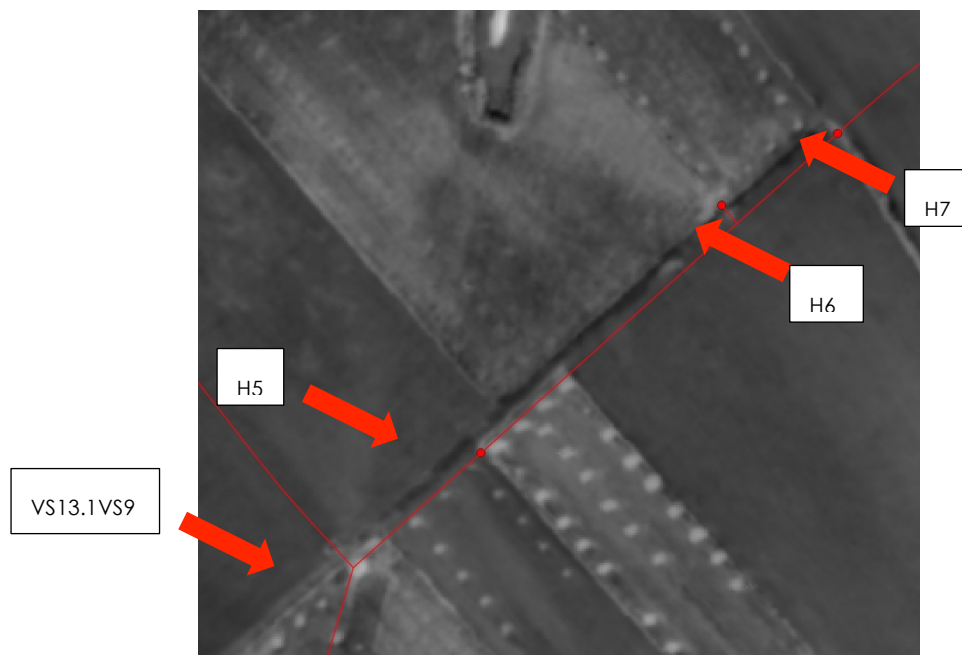
Figure 70 : WI map in the vicinity of hydrants H5, H6, H7. Moisture is significantly higher near H6; this high moisture area spreads in the north-west direction.

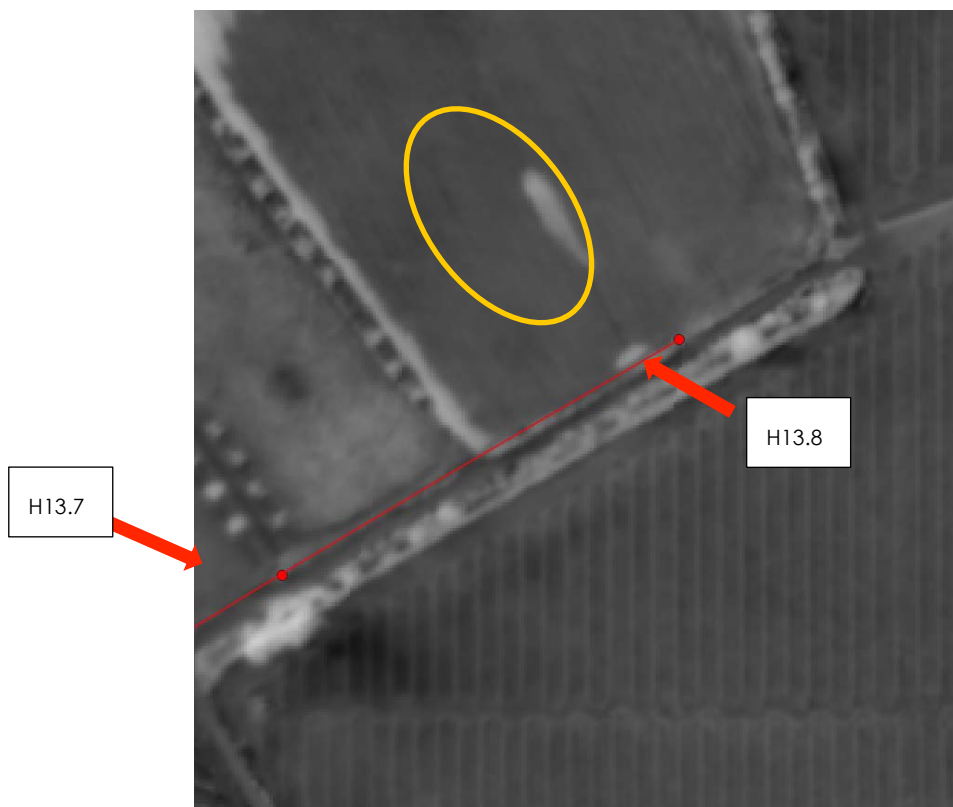
Figure 72 : WI map in the vicinity of hydrant H13.7 and H13.8. The bright spot south of H13.7 corresponds to a tree. A bright spot can also be seen close to H13.8, running south-west along the pipeline. Another elongated bright spot is highlighted by a yellow ellipse, in the north field. These two anomalies are not related to high vegetation and could thus be attributed to higher soil moisture. The presence of leak should be checked.

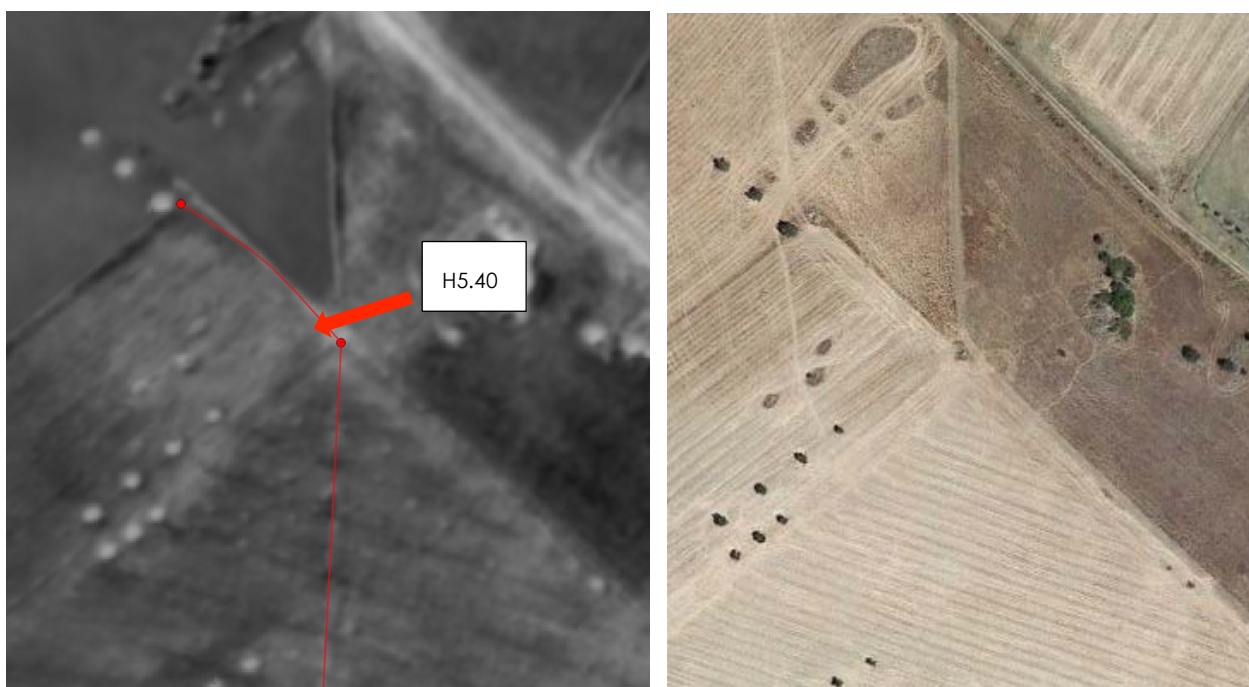
Figure 73 : WI map in the vicinity of hydrant H5.40 (left). The light grey area in the WI image around H5.40 is most probably related to the presence of denser or greener vegetation (as revealed on Google Earth image –right). A small water leak could thus be suspected.

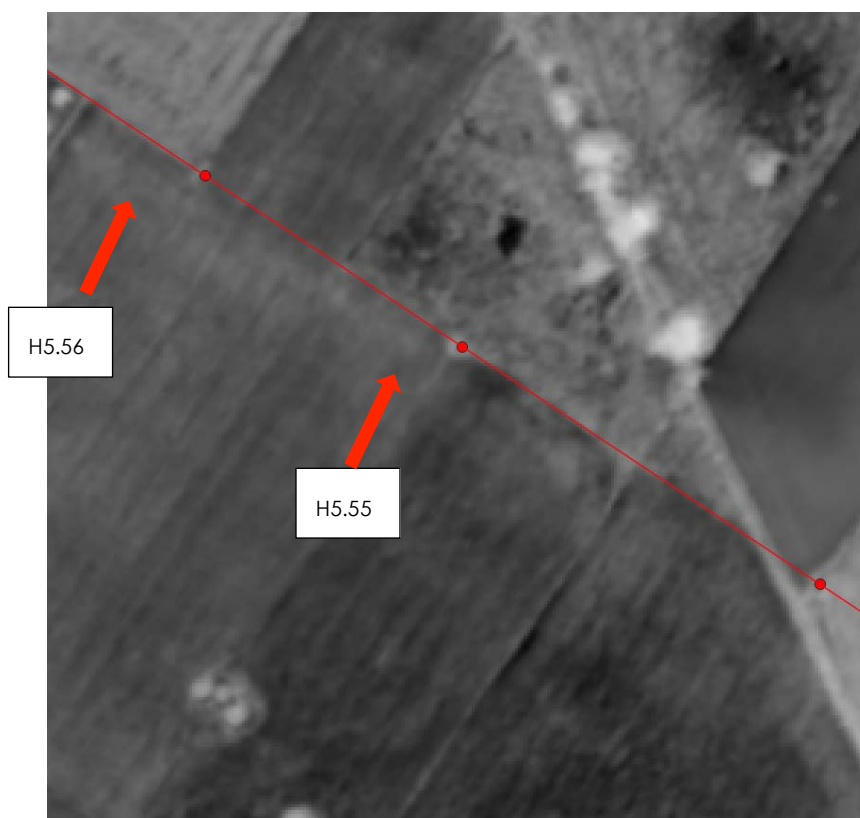
Figure 74 : WI map in the vicinity of hydrant H5.55 and H5.56. Both concrete blocks have the same size, however, the water index reveals a brighter spot around H5.55 as compared to H5.56. It should be checked if there is a difference in soil coverage (green grass as compared to dry grass or bare soil?), which could be interpreted as the presence of a small water leak.

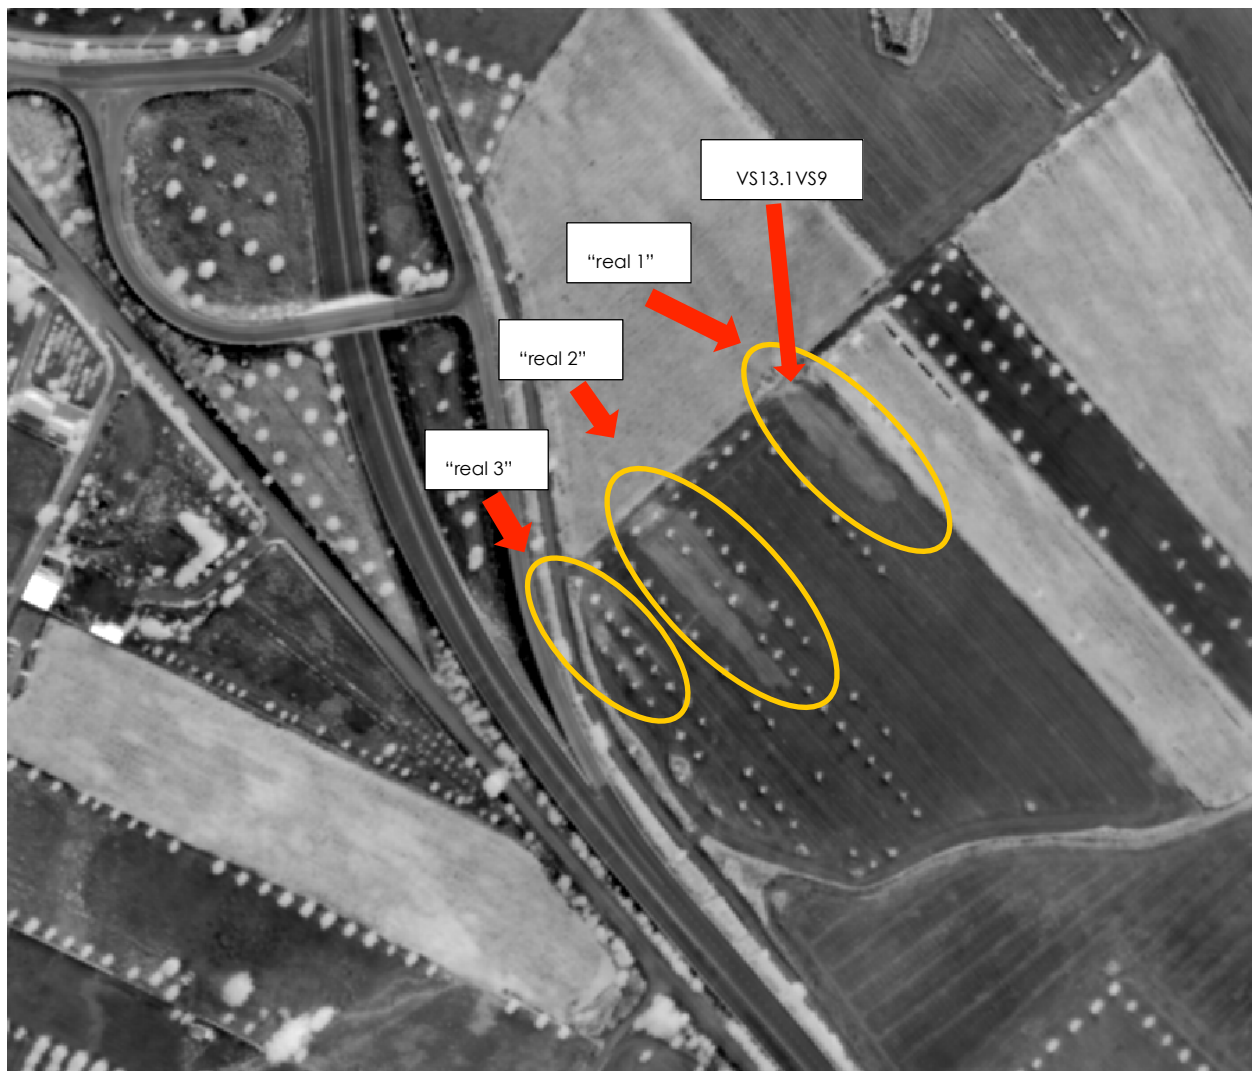
Below is a close-up over the suspected leak. It should be compared with Figure 43 of the moisture map obtained in May 2019. A “wet” area can be observed in September at the same place as what was suspected to be a leak in May (orange ellipses in fig. 43 and in the next figure). The “wet” area in September is however thinner than the bright area in May (in May the moist field extended from one olive line to the next one; in September it doesn't reach the west olive line). However, in September, two additional “wet” areas could be seen (as highlighted with a blue ellipse and a green ellipse), whereas nothing abnormal could be detected at these places in May. Notice also two other anomalies in the violet and red ellipses.

Figure 76 : Close-up of the WI map over the suspected leak area (Sept 11), Sao Manços

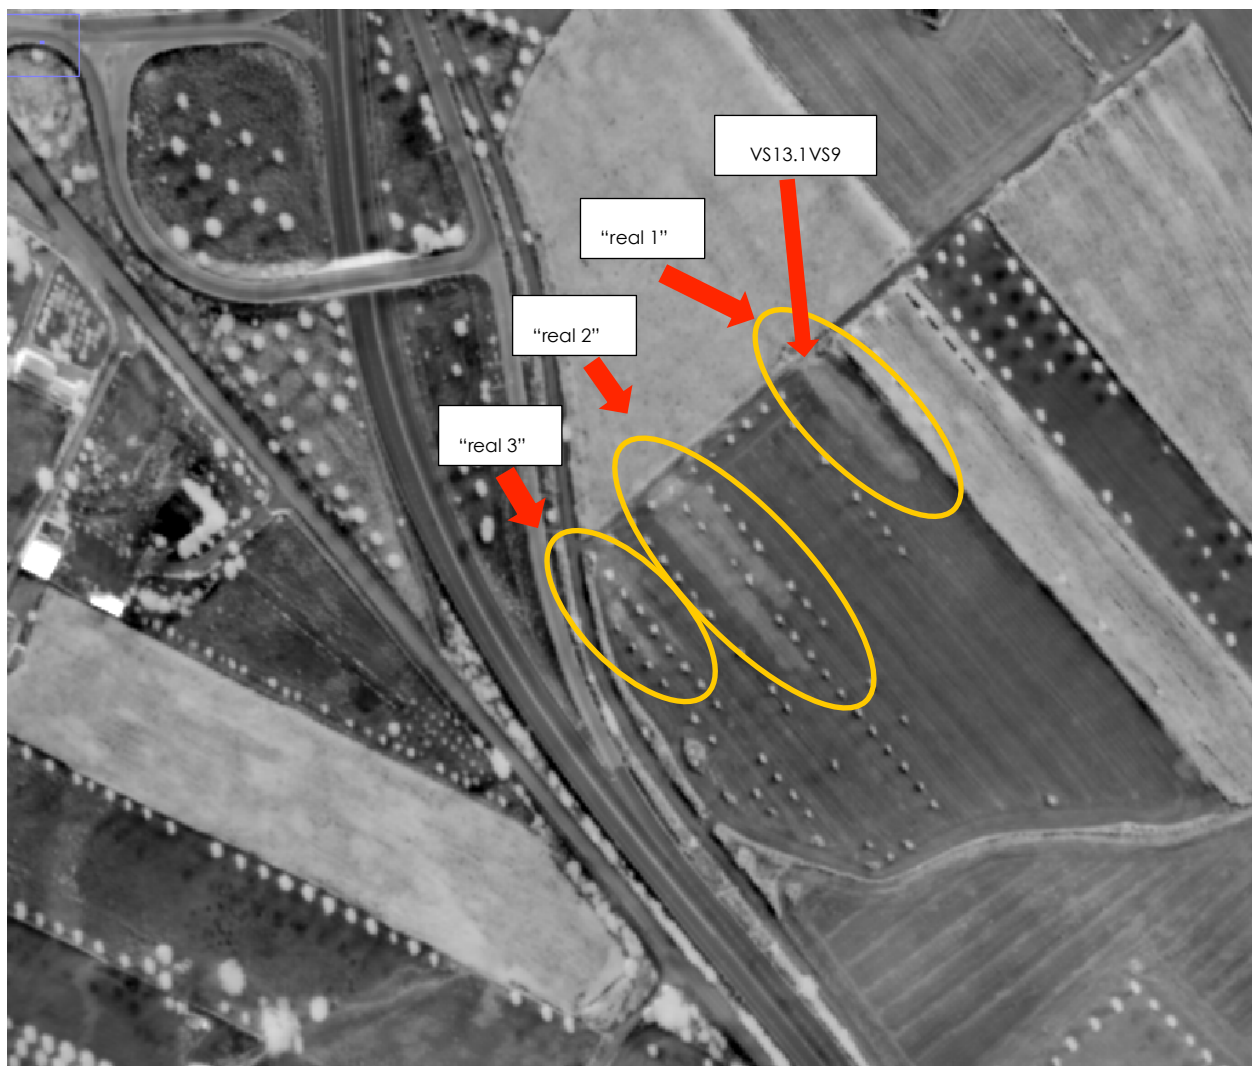
Figure 80 : Close-up of the WI map over the suspected leak area (Sept. 12). Notice that, as compared to the results obtained in May (see Figure 69), the area showing high water index called "real 1" is less elongated whereas it is the opposite for the areas called "real2" and "real3" (the most elongated of all three is now "real2").

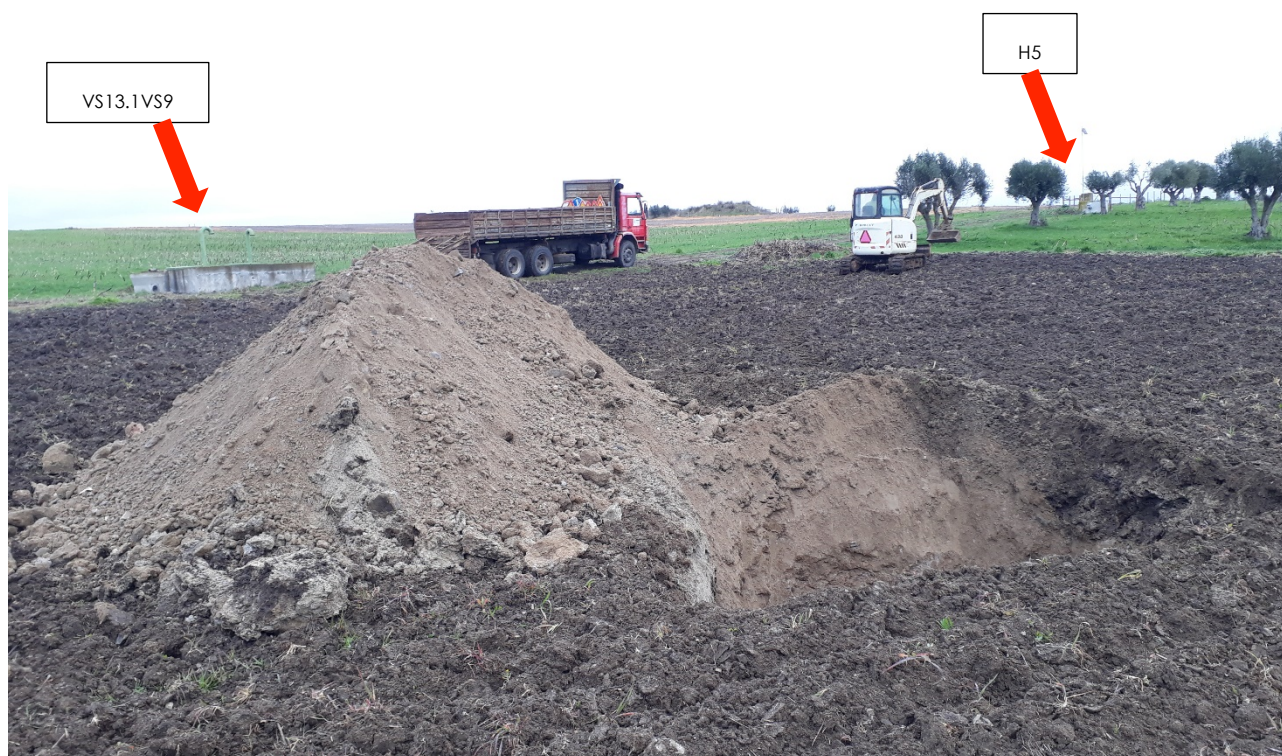
Figure 81 : Picture of the area close to the air valve VS13.1VS9, which is located in the concrete block at left. After the WADI airborne campaign, EDIA dug the soil a few tens of meters south of VS13.1VS9, in the zone corresponding to “real 1”. Below the surface, the soil was found dry as seen on the picture. Hence, the high water index in the zone “real 1” in Figure 69 and Figure 80 cannot be attributed to a real leak originating from the pipe at air valve VS13.1VS9.

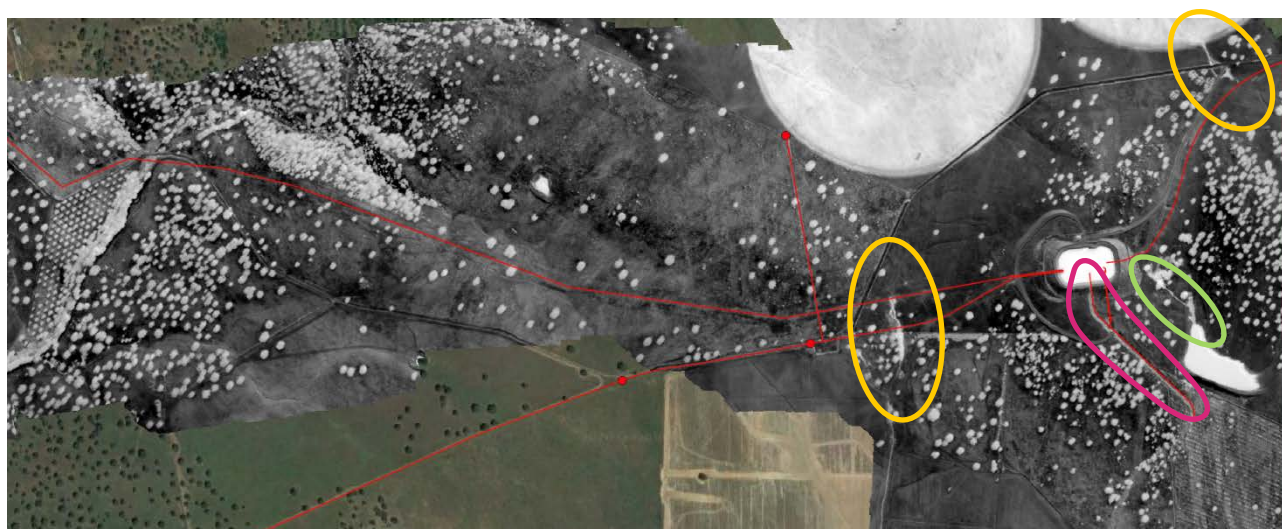
Figure 84 : Sept 11th. 2019, MAV flight, Close-up of the WI map near the reservoir. Two suspected leaks are highlighted with orange ellipses, Vale de Gaio.

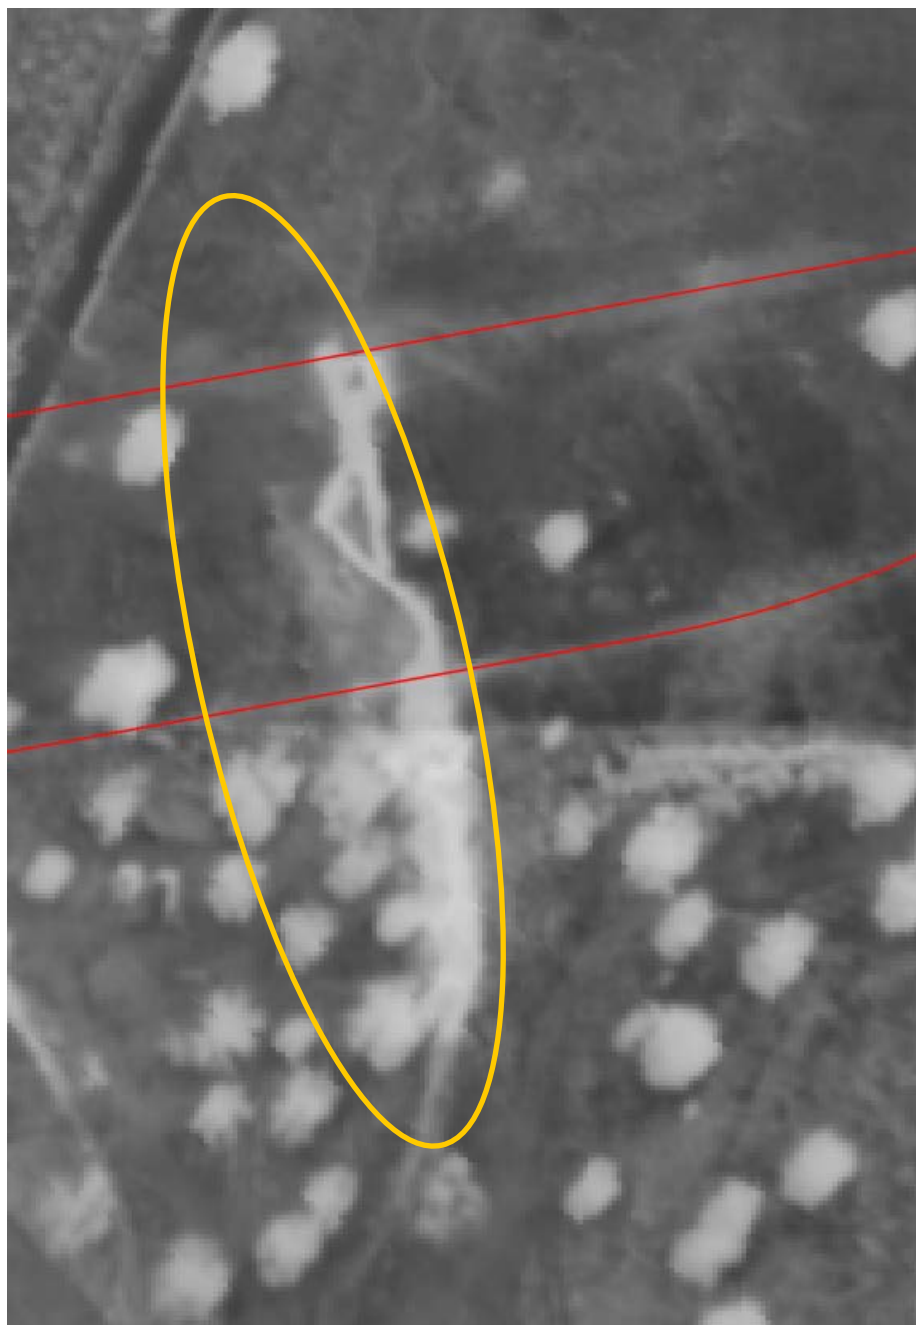
Figure 85 : Vale de Gaio. WI image (Sept. 11th) of a suspected leak west of the reservoir.

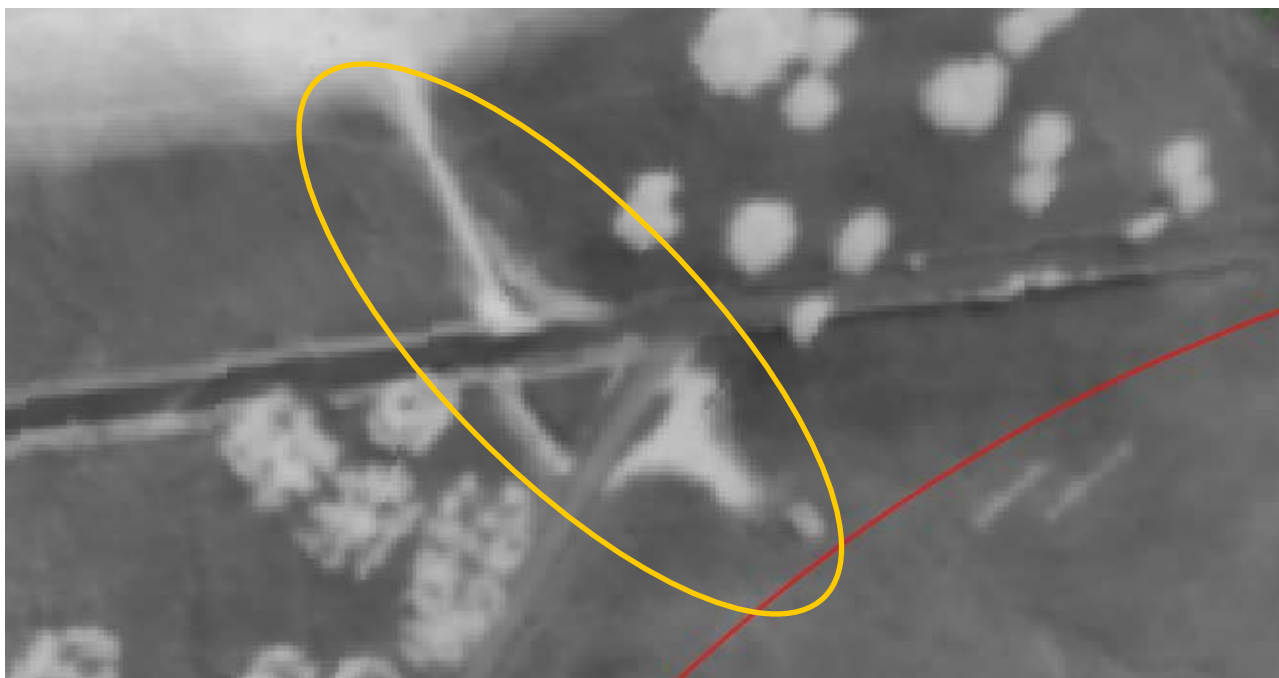
Figure 86 : Vale de Gaio. WI image (Sept. 11th) of a suspected leak north-east of the reservoir.

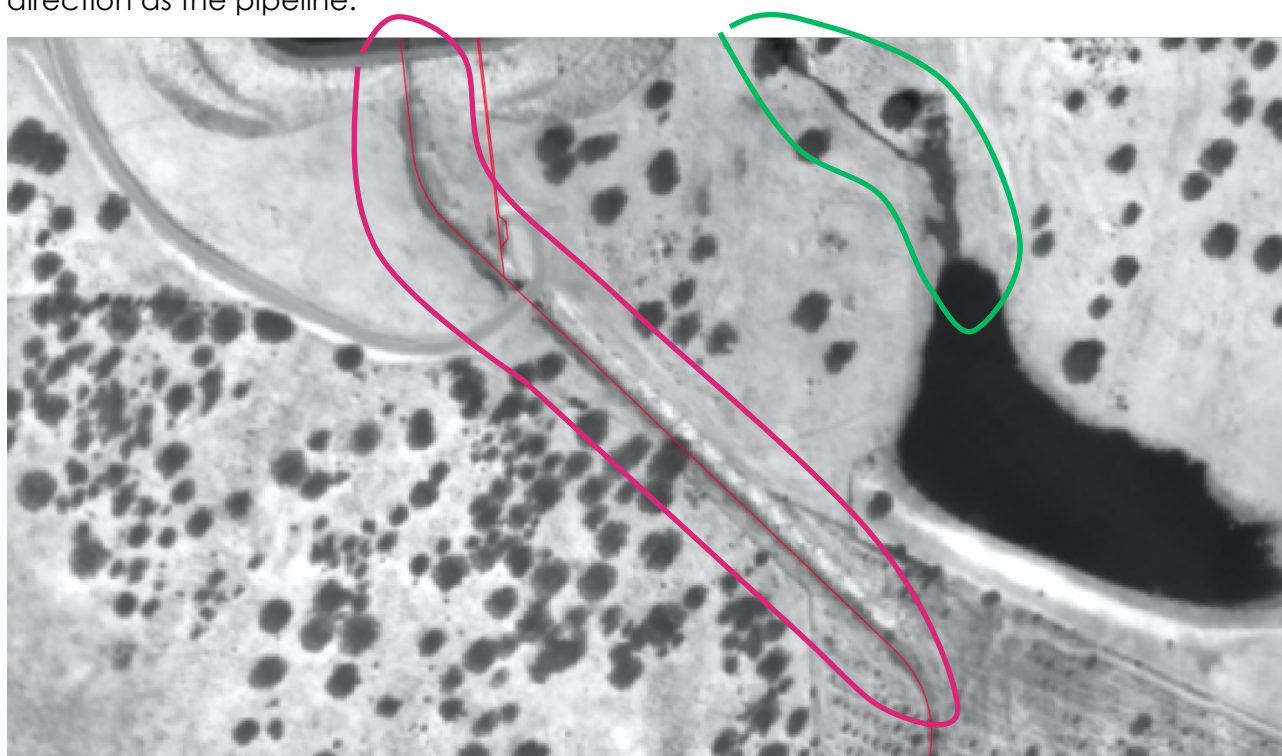
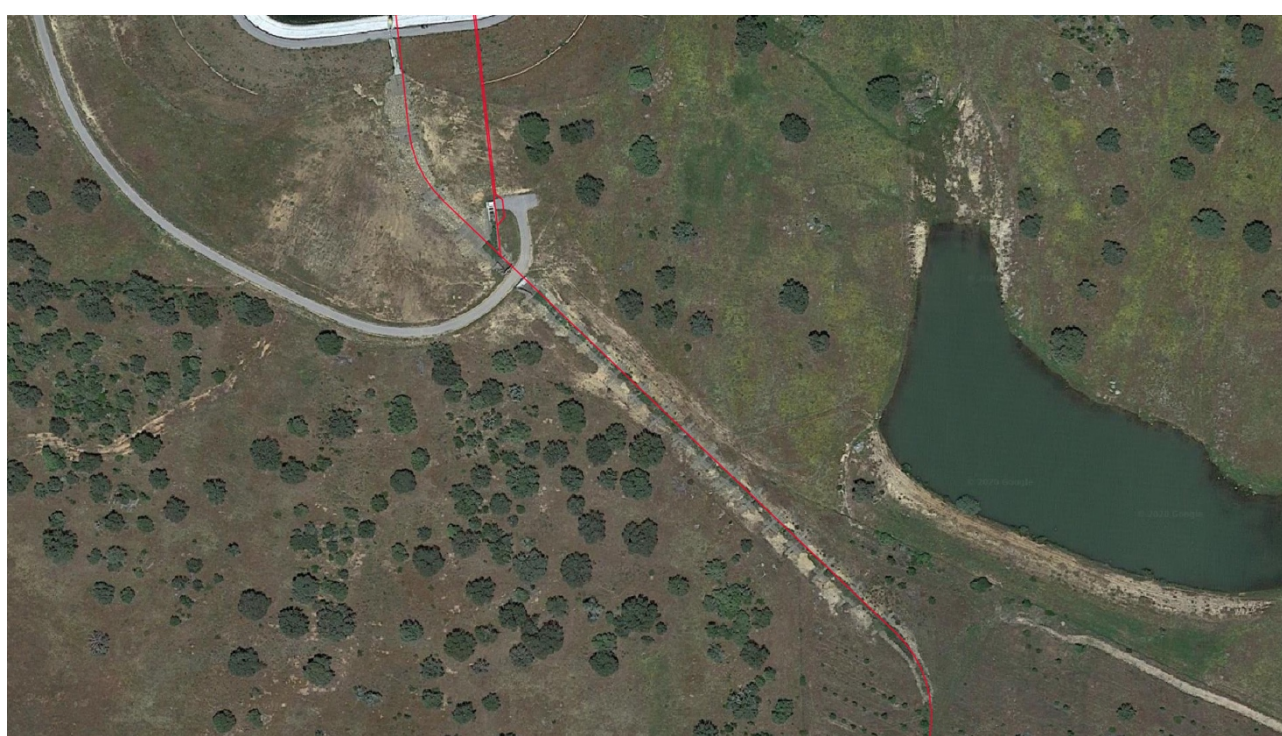
Two other areas as revealed by magenta and green closed curves in Figure 84, south and south-east of the reservoir, showed a very low temperature.

Figure 88 : Vale de Gaio. Thermal infrared image (top) (Sept. 11th) showing two anomalies with excessively low temperature running south and south-east of the reservoir.
