Water-tightness Airborne Detection Implementation

D6.1 - Operational and surveillance demonstrations on water supply and irrigation mains in Portugal - update

Authors: ONERA, GG, AM, SGI, EDIA

31st May, 2020

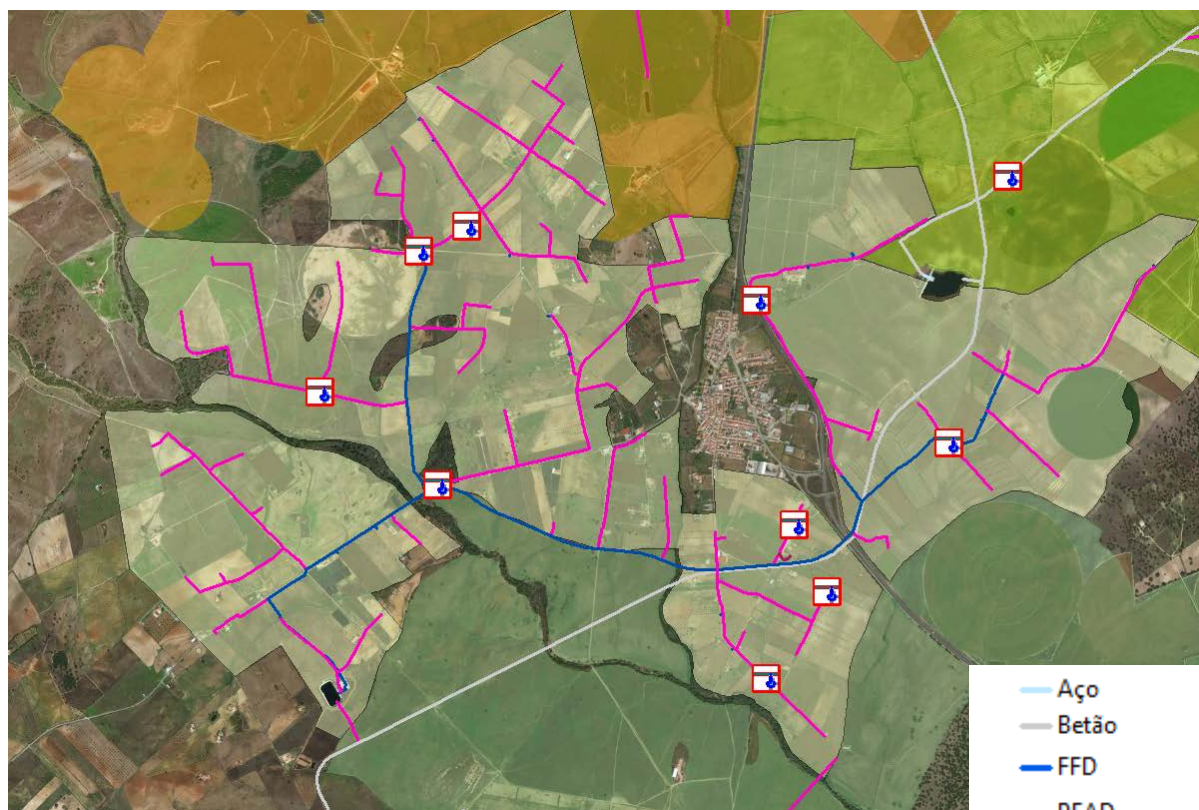
Figure 19 : material & location historical leaks on block N°2, Monte Novo

To select the area where to carry-out the test for WADI, it was asked to EDIA the historical records of leak repair to understand which block had a higher probability to present issues: within Block n.2, 9 repairments have been reported since 2012 which potentially indicated an area where leakages could occur with higher possibilities.

Another object of assessment regarded the material; as mentioned metallic pipes are the best field of application for ground leakage detection acoustic methods and as already expressed the majority of EDIA's pipe are in cement and plastic, but Block n.2 presents also a good percentage of metallic pipe (ductile iron). Figure below shows the pipe material and the location of historical leak for Block n.2.

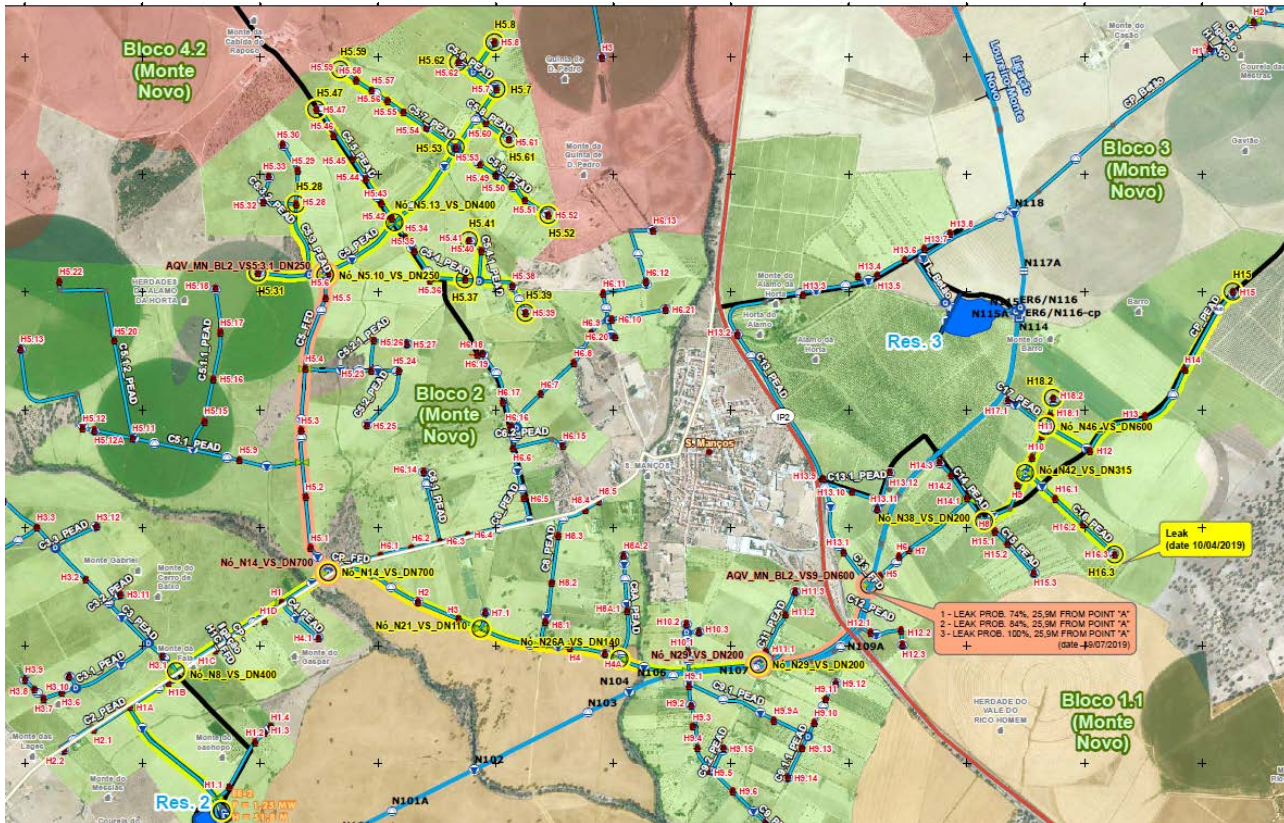
Figure 20 : investigated pipes on GLD campaign, Monte Novo

In agreement with EDIA's staff only part of the network was investigated through the acoustic campaign, namely 7.2 km of metallic pipe and 7.9 km of plastic pipe for a total of 15 km out of 33 km. The campaign was carried out in April-May 2019 for a first part and concluded in July 2019. Highlighted mains in the Figure 20 below shows the investigated pipes.

One positive result was registered, on Hydrant H16.3, which was identified as a small superficial leak (in a tube on the hydrant, and not in an underground pipe).

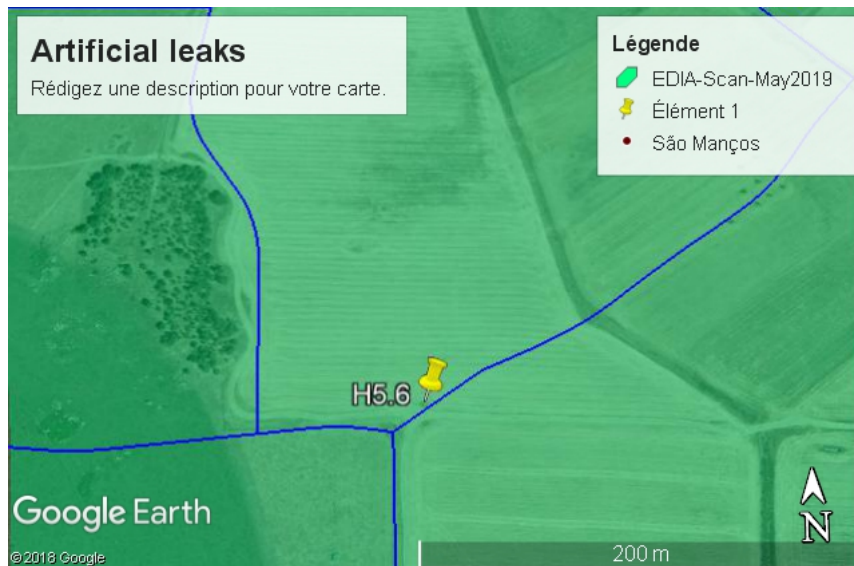
Figure 25 : HP5.6 artificial leak, Monte Novo

- Zone Block 2 Artificial leak N°2 HP5.6 (vegetation)

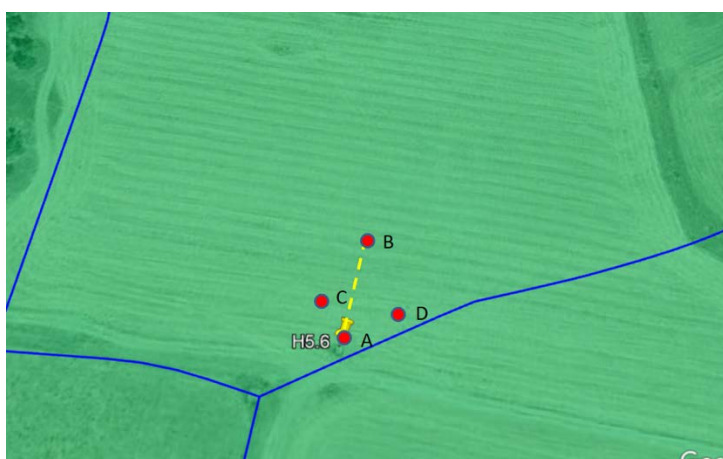
Figure 28 : Location of measurement on H5.6 area, Monte Novo

- tap: 10h44 (open) 11h21 (closed) – elapsed time : 37 mn irrigation
- Wet area: 6m in front of the pipe, 3m left, 5 m right
- Airplane take-off from Evora : 11h37
- Airplane altitudes : 800 – 1000 – 1200 m
- Soil Humidity measurements (probe N°1) : Universal soil
- GPS + tablet
- After the leak

Time	Measurement point	Humidity (%)	Soil Temperature (°C)	Surface temp (°C), emissivity=1	Localization
11h31	A	33	22	26	1m from the leak In front of the pipe
12h36	B	30	25	26	6m from the leak In front of the pipe
11h40	C	22	27	30	3m on the left
11h44	D	34	29	30	6m on the right

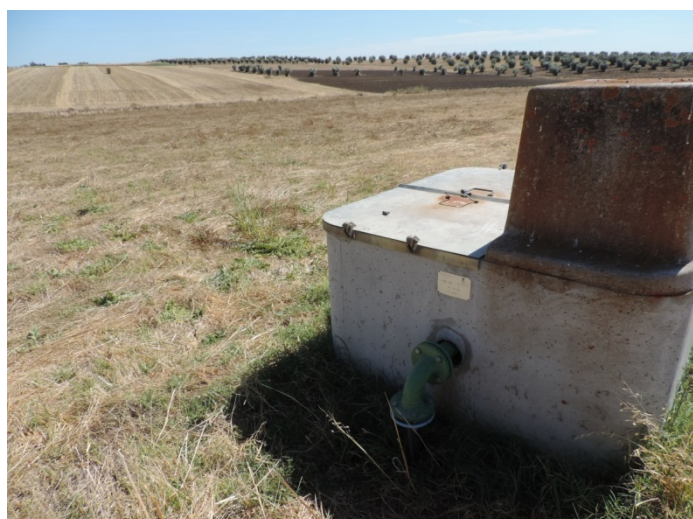
Figure 35: H10 site, Monte Novo.

- Monte Novo artificial leak Zone H10 (dry grass soil, 14h45)

At the leak: SMC= 7%, Tsoil = 34°C

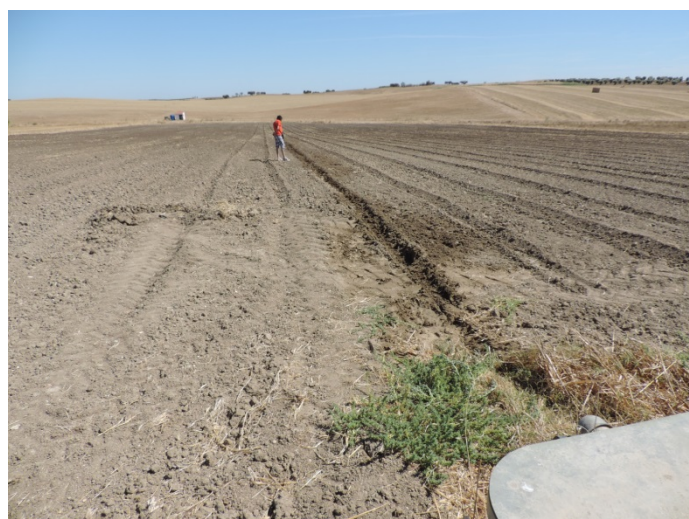
Figure 36: H11 site, Monte Novo.

- Monte Novo artificial leak Zone H11 (dry earthy soil, 14h55)

At the leak: SMC = 30%, Tsoil = 33°C

10 m far from the leak : SMC = 10%

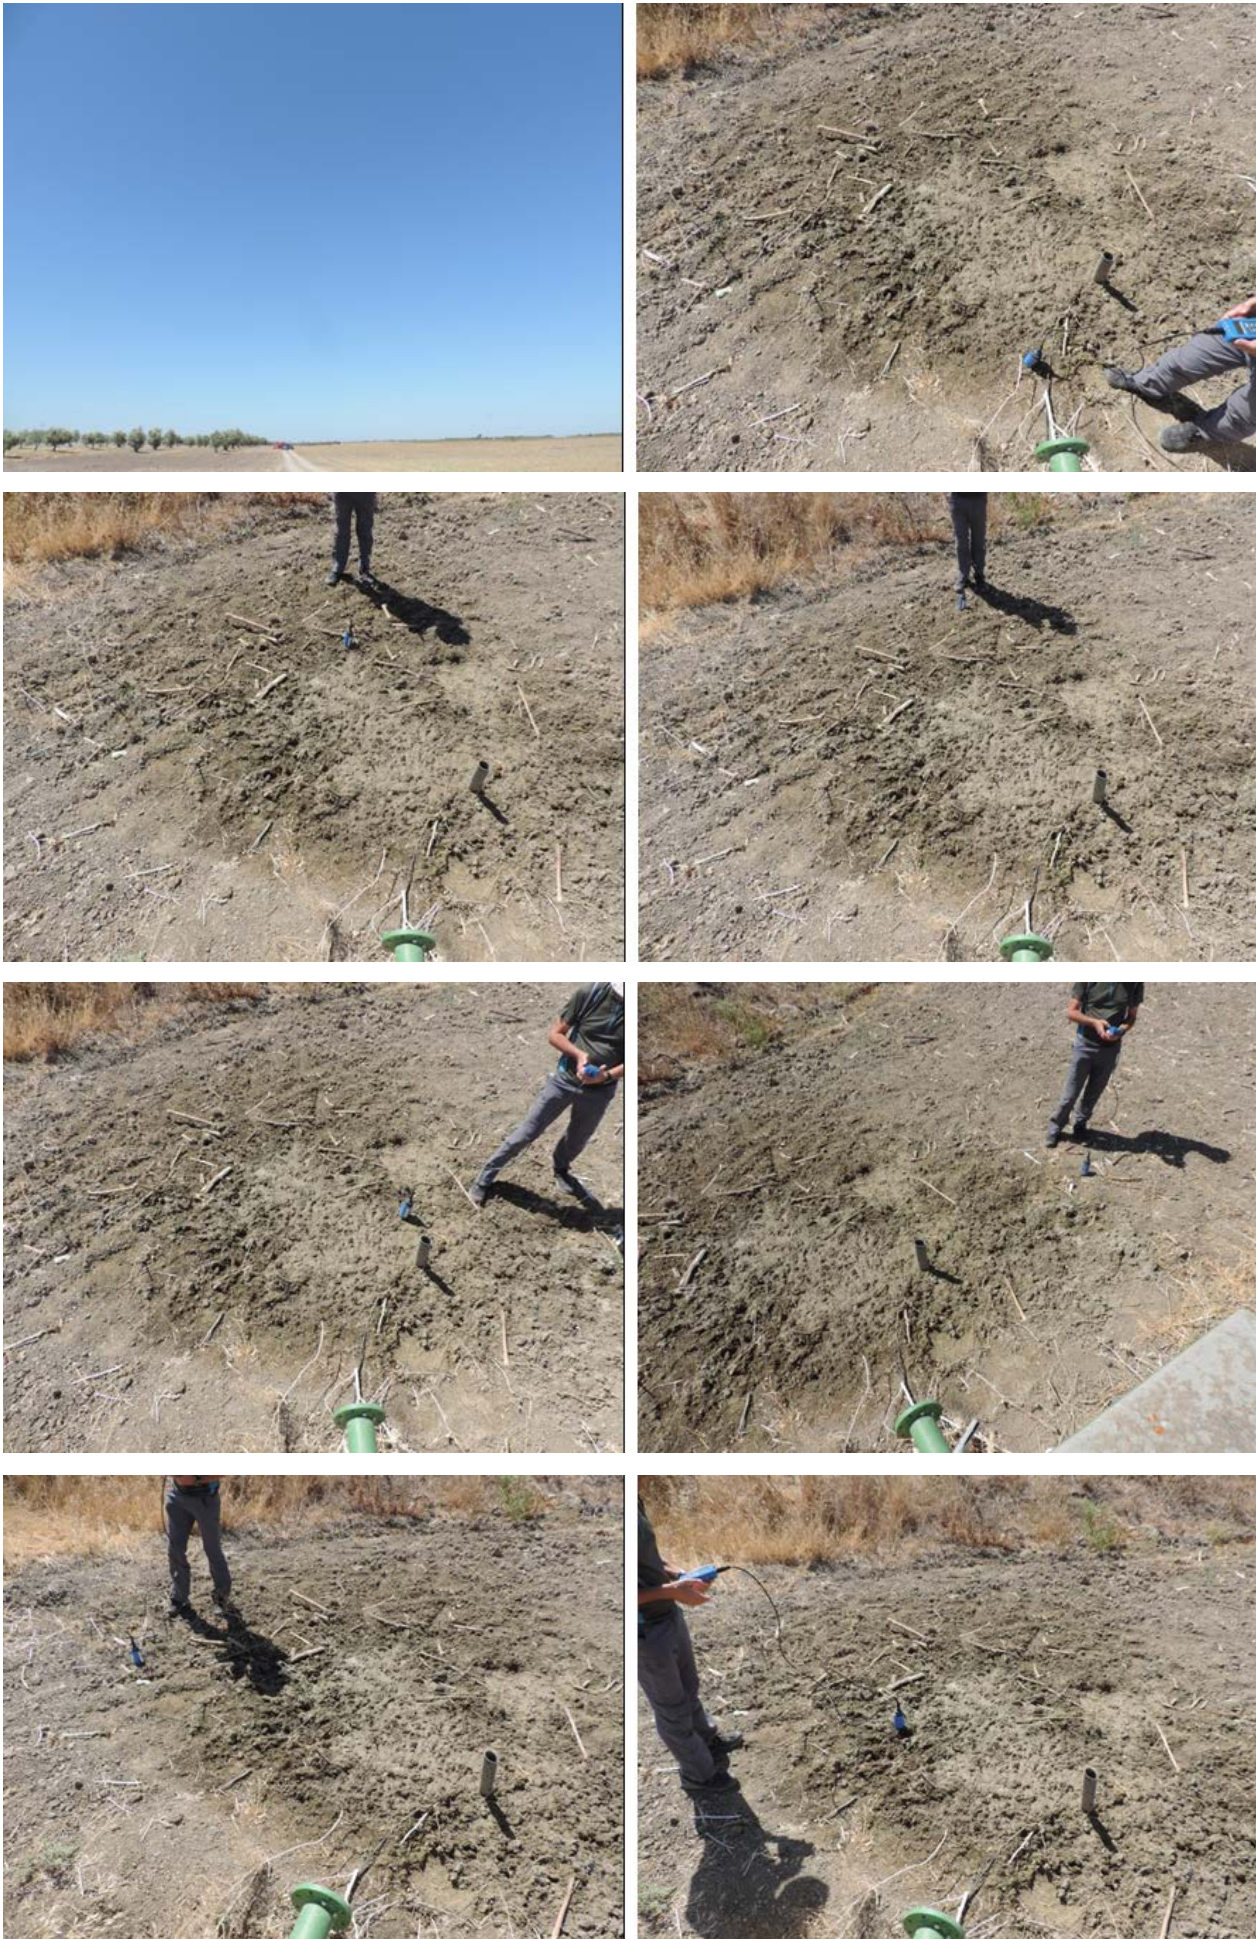
Figure 37 : Photos from H9.7 artificial leak, Ferreira

- Ferreira artificial leak Zone H9.7

Leak dimensions: 3 m x 3 m.

Ground temperatures (measured by pyranometer): 27°C (at the exit of the green pipe), 24°C (in the middle of the leak), 30°C (at the end of the leak), 29°C (on the right side of the leak when seen from the green pipe), 44°C at 5 m on the right of the right side of the leak, 25°C (on the left side of the leak), 34°C (dry grass), 38°C (top of concrete block), 40°C (green metal plate), 42°C (earthy track).

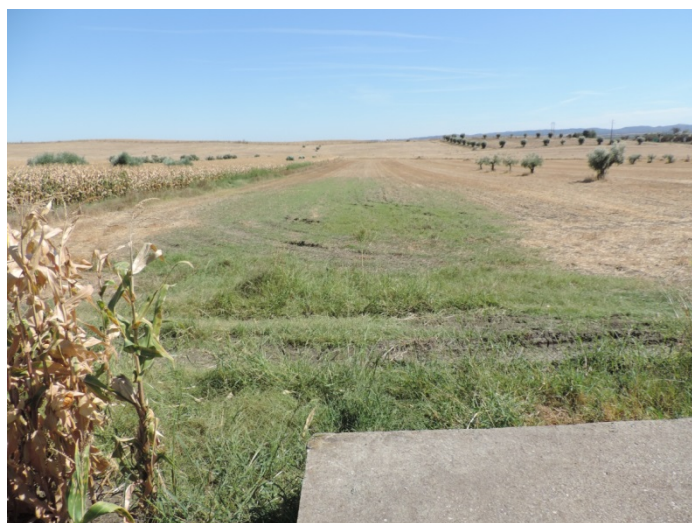
Figure 46: H5 site, Monte Novo.

- Monte Novo « natural leak » Zone H5 (dry grass soil, 14h45)

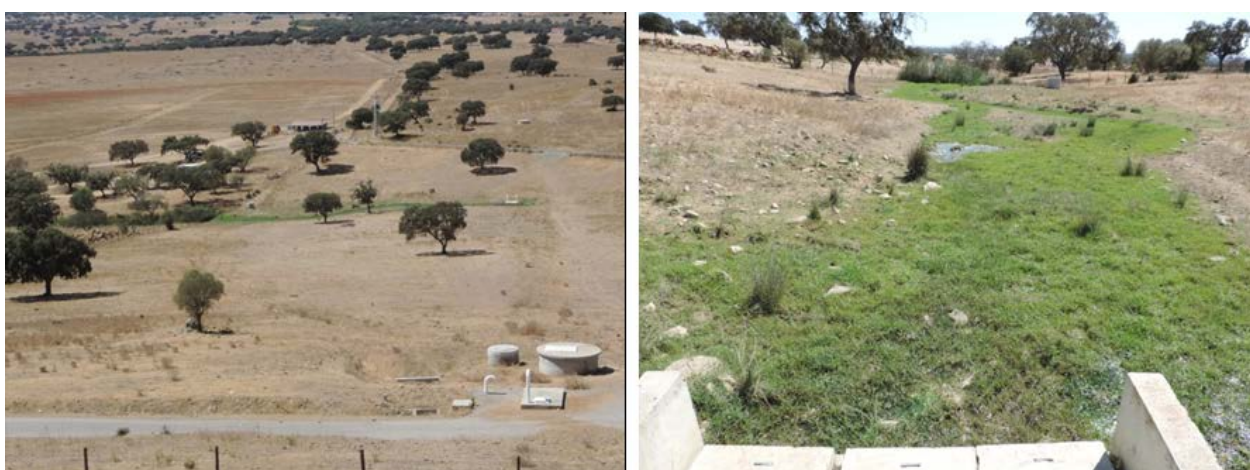
Figure 53: Vale de Gaio “natural leak” 2, west from the reservoir. Leak as seen from the reservoir (left) and close up of the leak (right).

Leak orientation: N-S, dimensions : ~ 60 m x 15 m

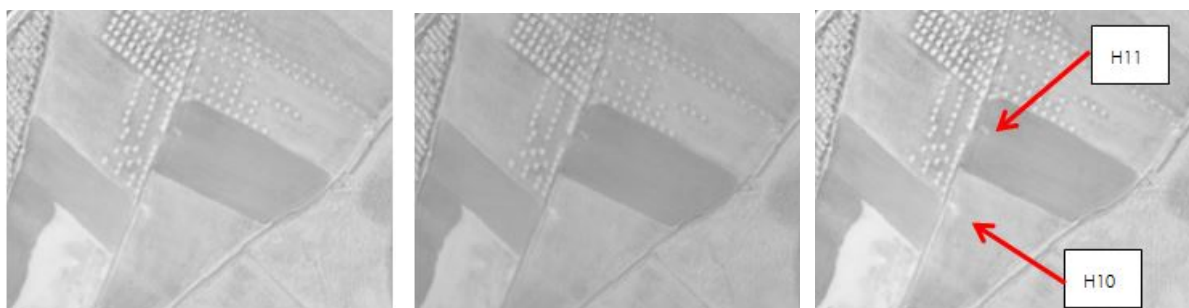
Figure 64 : Moisture maps around H10 & H11 according to Processing 1, 2 and 3 (from left to right). The leaks H10 and H11 are clearly seen.

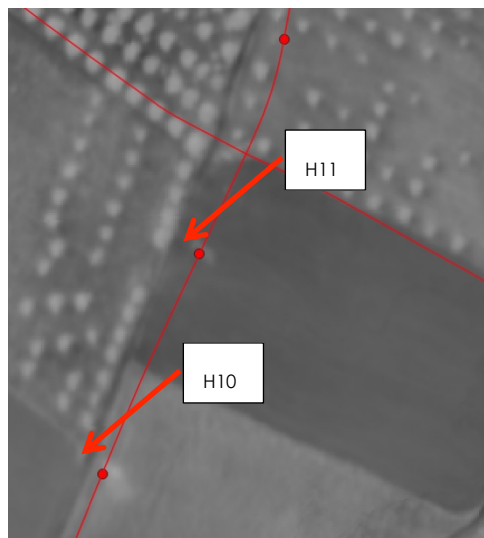
Figure 65 : Moisture map around H10 & H11 together with the pipeline

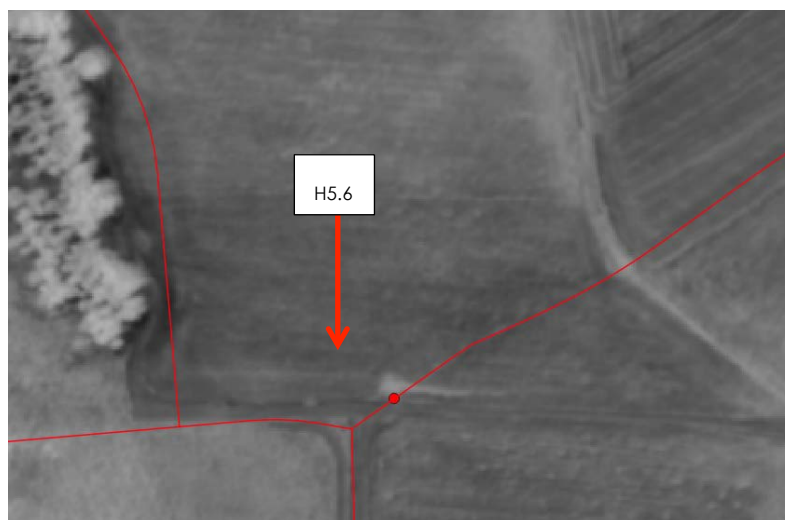
Figure 67 : Moisture map (close up in the area of the artificial leak H5.6) as obtained according to Processing 3, together with the pipeline.

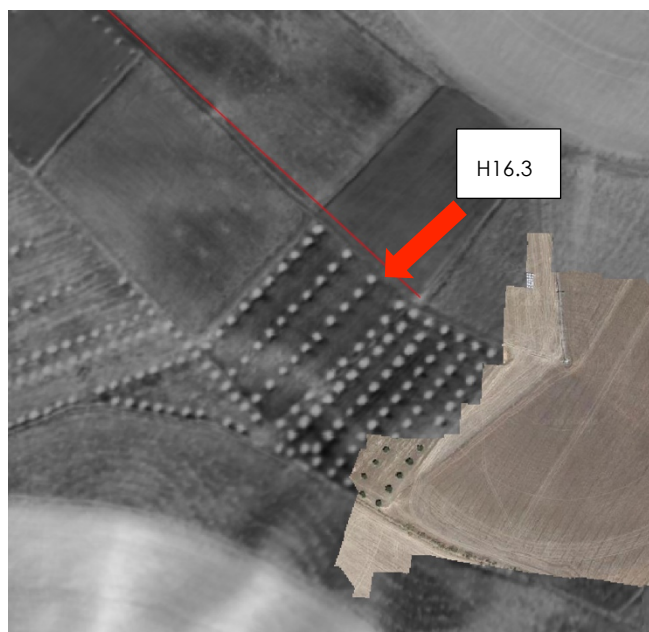
Figure 71 : WI map in the vicinity of hydrant H16.3. A small leak was detected by SGI at this hydrant. A slight moisture contrast (light grey) can indeed be seen in close vicinity of H16.3.

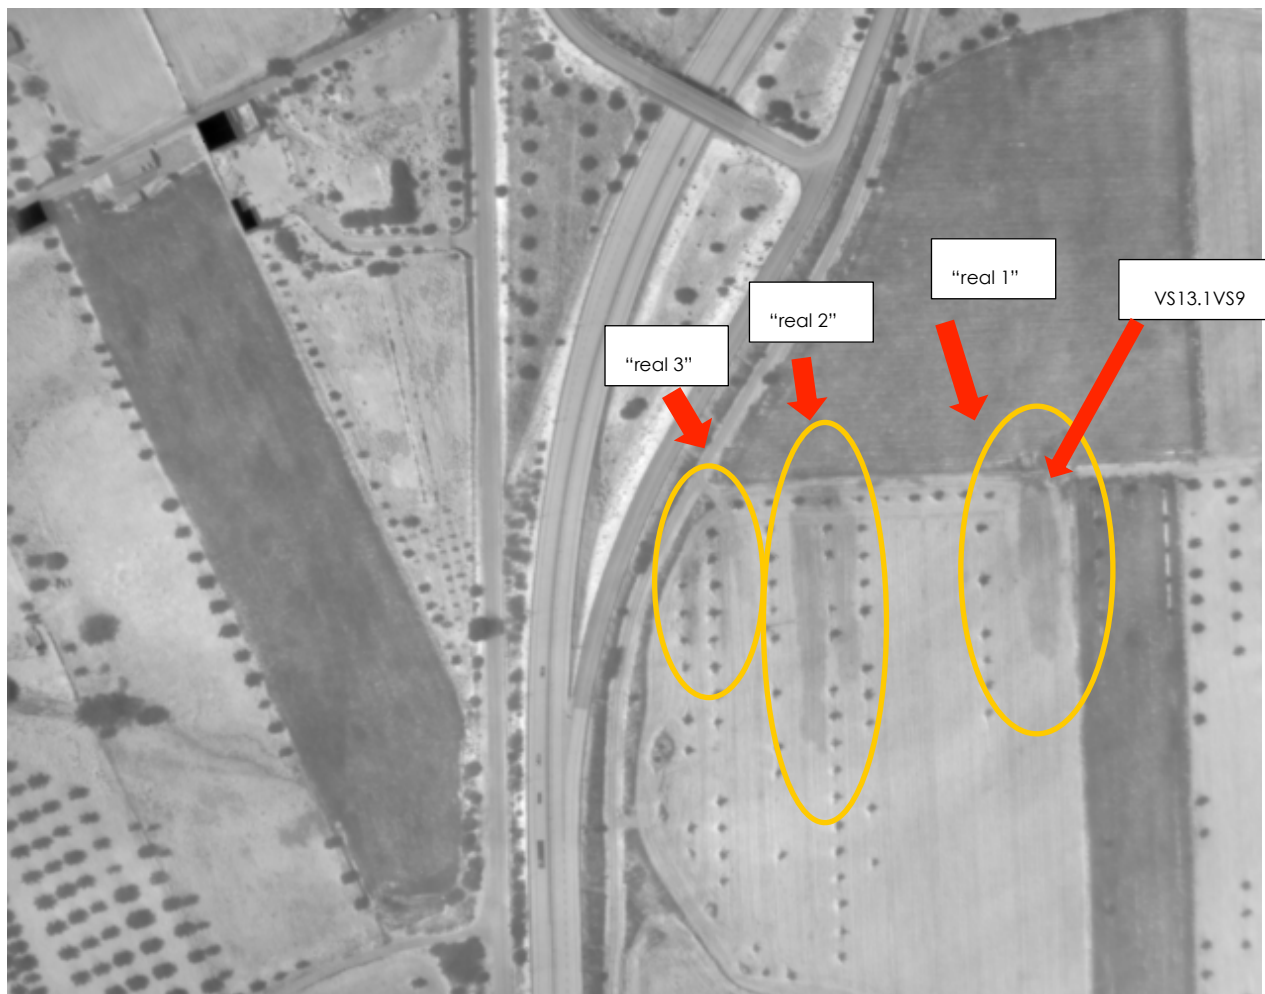
The Thermal infrared image obtained over the Sao Mancos area (before georeferencing and mozaïcking) is reported thereafter. It should be compared with Figure 68, Figure 69 of the moisture map obtained in May 2019 (beware the contrast in a thermal image and a water index image is of opposite sign!).

Figure 77 : Raw thermal image over the suspected leak area (Sept 11)

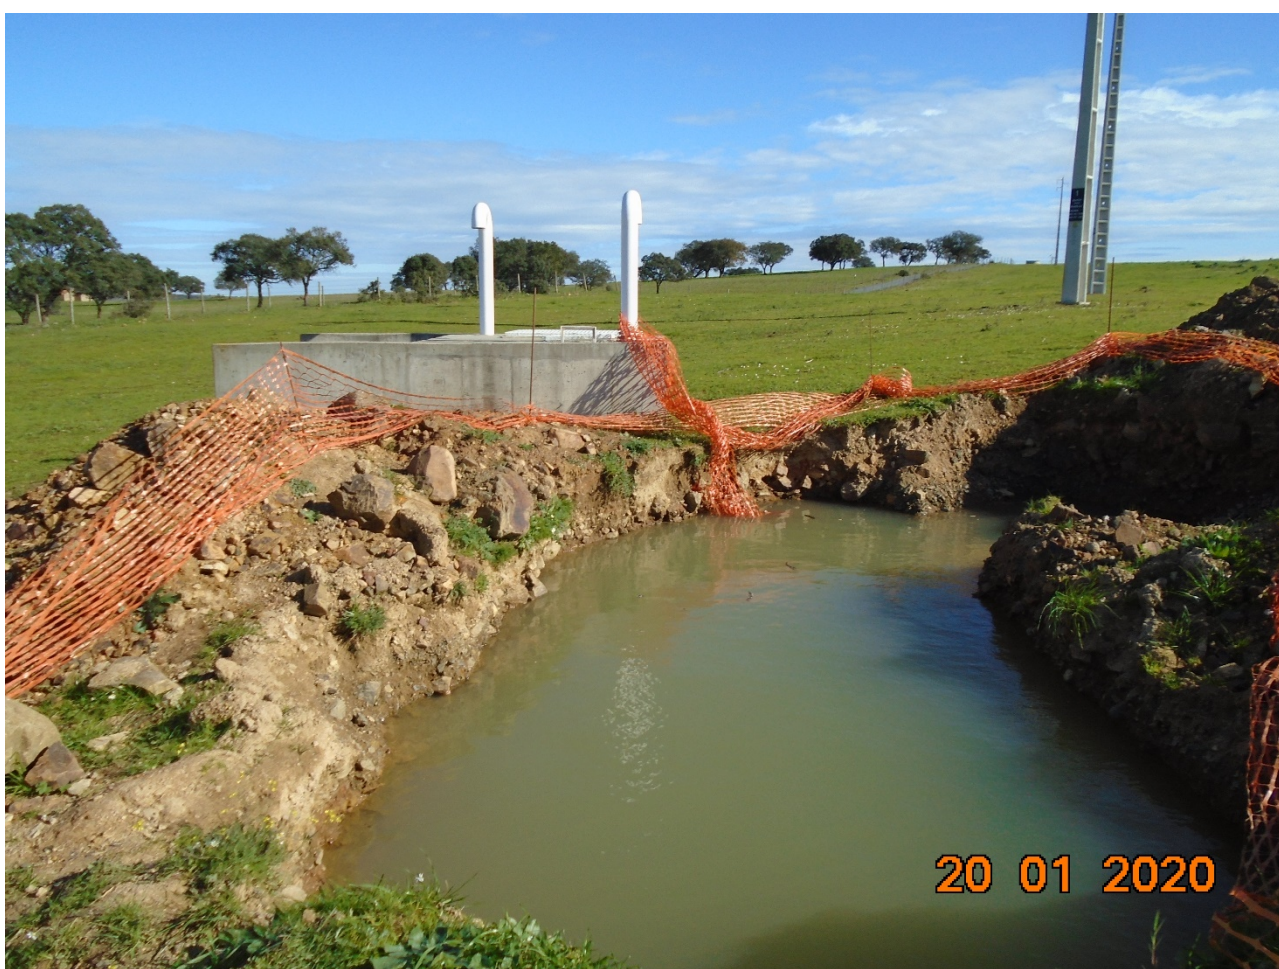
Figure 87 : Picture of the area close to the air valve north east of the reservoir.

After the WADI airborne campaign, EDIA dug the soil close to the air valve, at the origin of the water flow seen on the surface and reported in Figure 86. The water flow was not attributed to a leak of the pipe running nearby. As a matter of fact, water was found in the hole that EDIA dug. Then During two weeks EDIA emptied the adductor and the reservoir but the water did not disappear in the dug hole, it kept the same level. A few days later, it rained and the level increased in the dug hole. The final interpretation is that the observed water is originating from the water table.

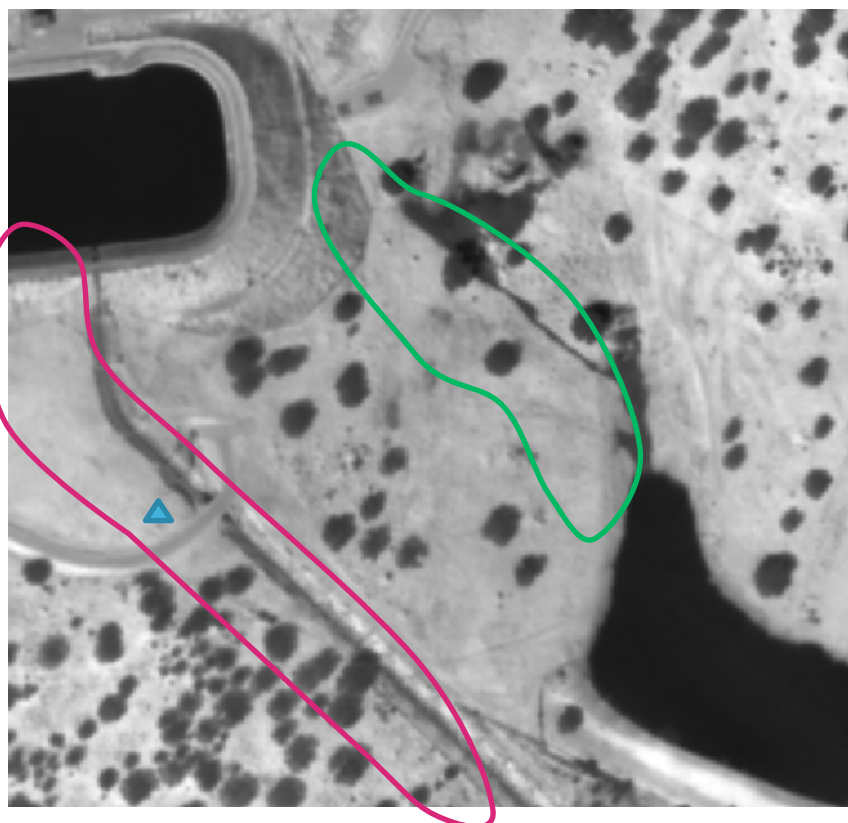
Figure 89 : Vale de Gaio. Thermal infrared image (Sept. 11th)

This figure is showing two anomalies (excessively low temperature) as delineated by magenta and green closed curves. The green closed curve shows a natural stream that flows south-east of the reservoir towards the pond below.

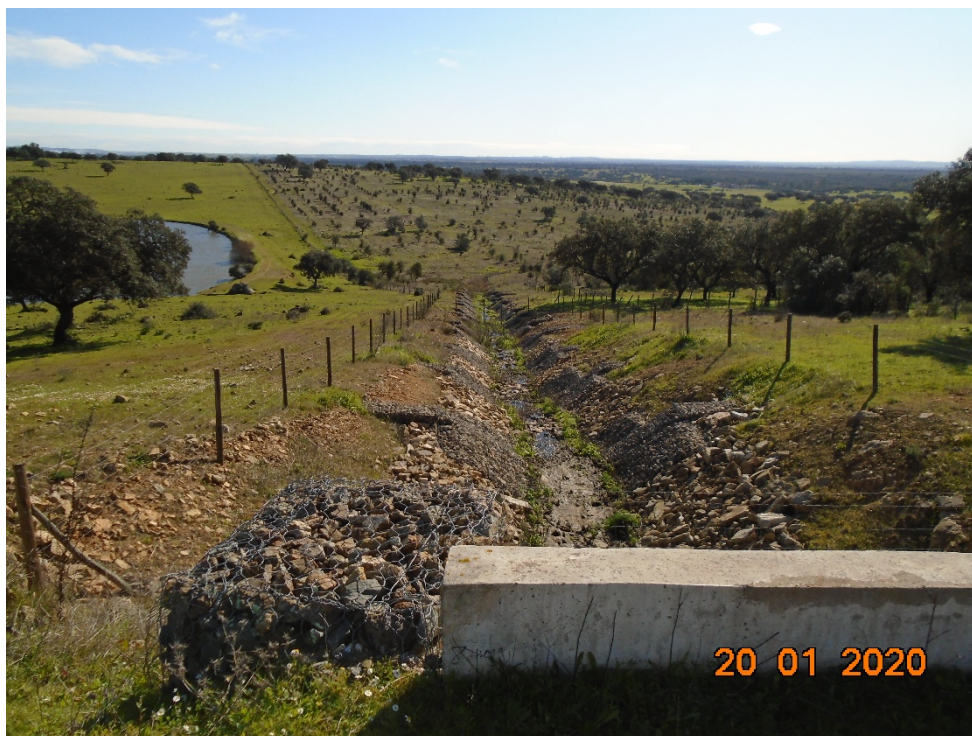
Figure 90 : Vale de Gaio. Picture taken from the road (see the blue triangle in Figure 89) in south-east direction.

It shows the spillway of the reservoir.

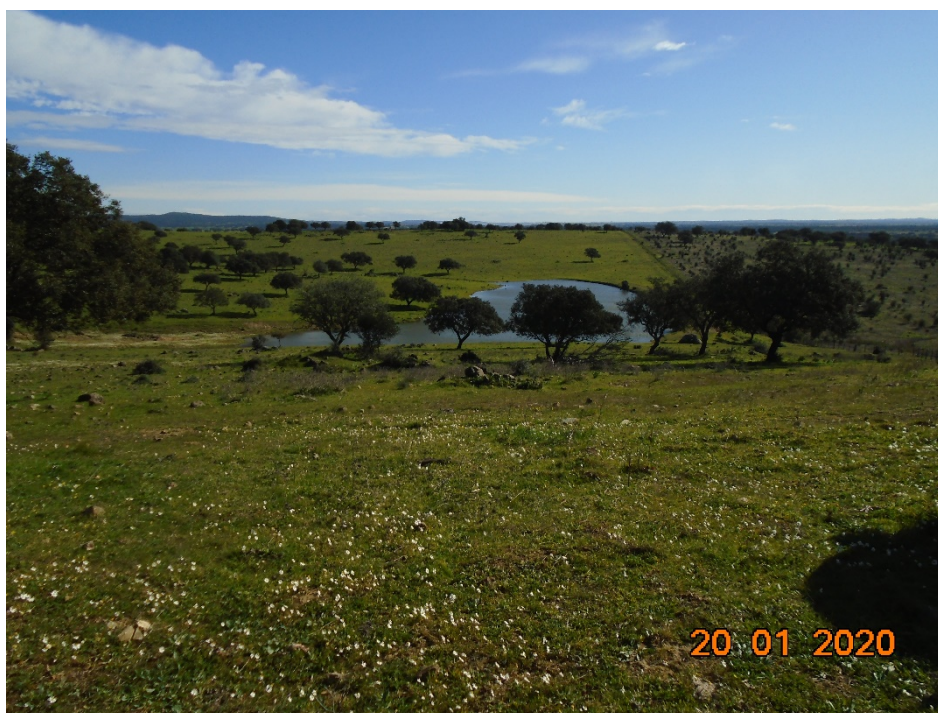
Figure 91 : Vale de Gaio. Picture taken in the direction of the pond, southeast of the reservoir. The natural stream comes from the left in the picture and ends in the pond.

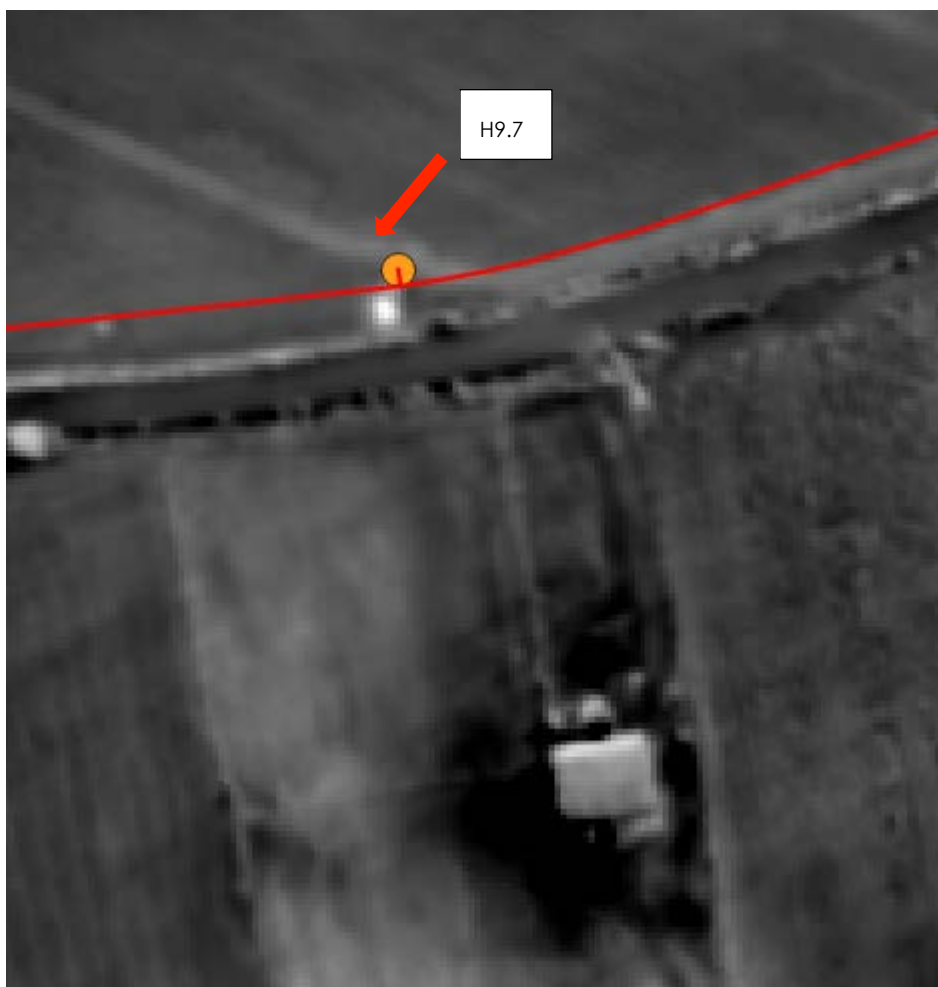
Figure 93 : Ferreira area. Hydrant H9.7 (artificial leak).

A high contrast is observed in the water index image which is attributed to the high moisture of the soil near the hydrant.

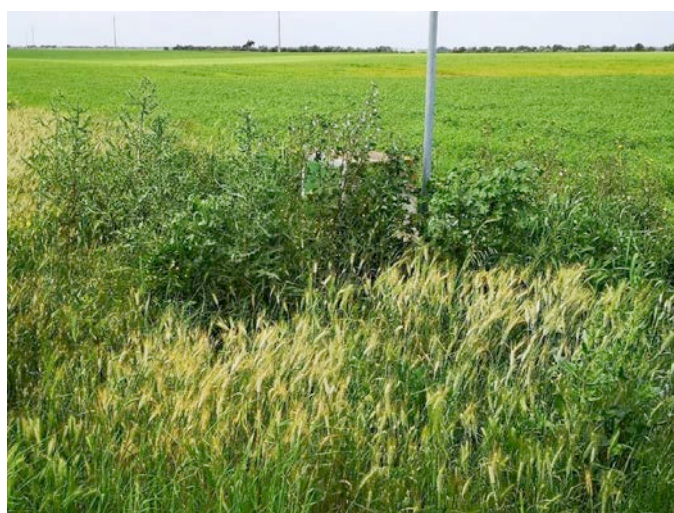
Figure 94 : Ferreira area. Hydrant H9.7. Photo taken on April 16, 2020 in west direction (see Figure 37 for a picture taken in Sept. 2019).

The hydrant was not used for irrigation last campaign in Sept. 2019 but it was used for simulating a leak. The presence of vigorous weeds seven months later might indicate the existence of a possible *real leak* but at the same time it is normal to find this kind of vegetation near the infrastructures due to the absence of herbicides or soil harrowing.

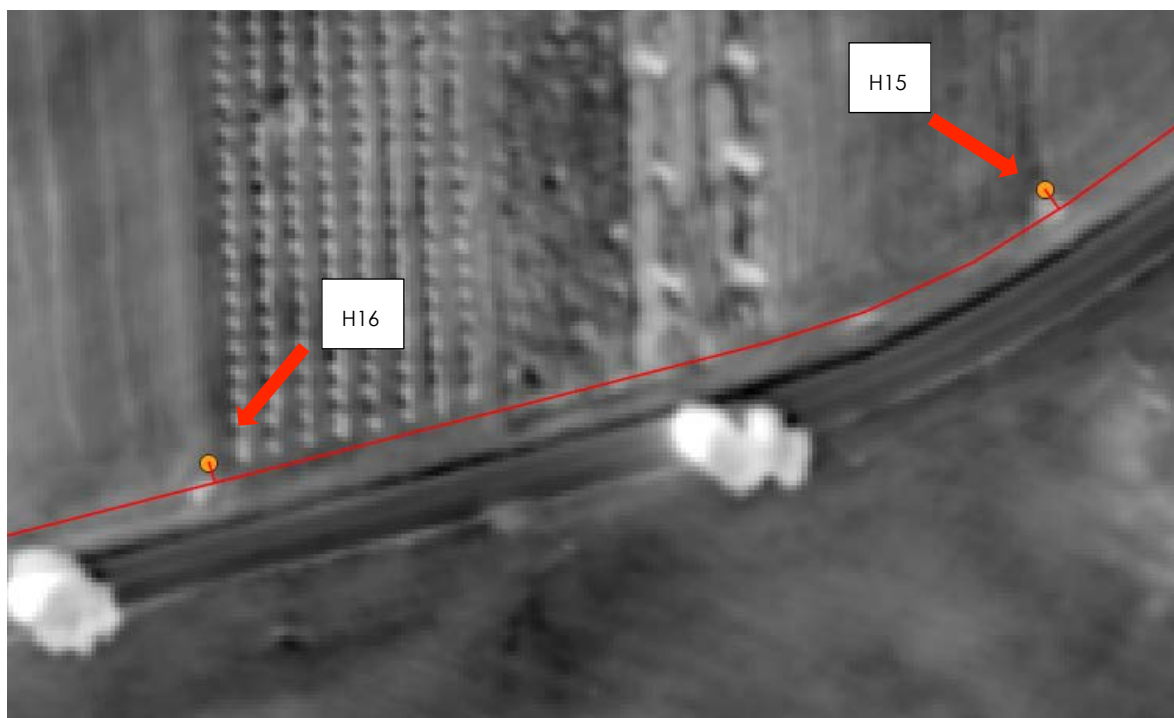
Figure 95 : Ferreira area. Artificial “leak” at hydrant H16 (left).

A significant contrast of the water index is observed in close proximity (it is nevertheless lower than at hydrant H9.7 – compare with the previous figure). A significant contrast is also observed near hydrant H15 (right). This anomaly should be checked for a potential leak.

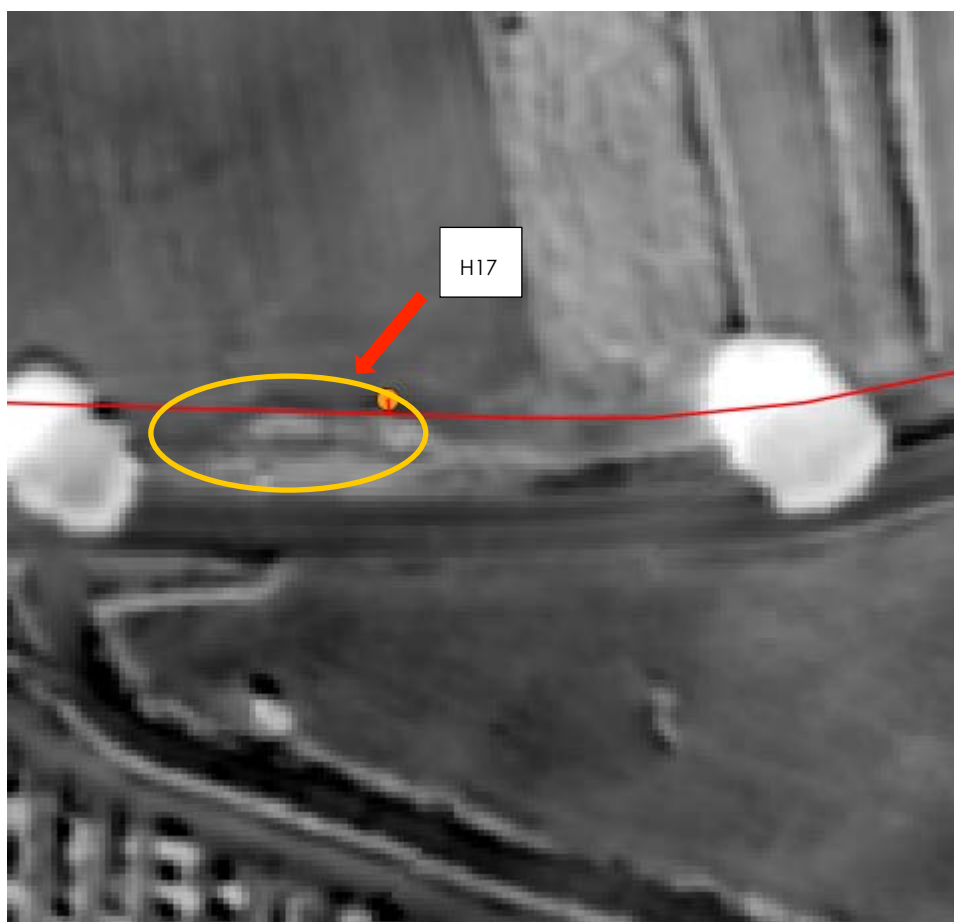
Figure 96 : Ferreira area. Hydrant H17.

A large area with high water index is seen spreading on both sides of H17 (see the orange ellipse). This anomaly was checked for a potential leak.

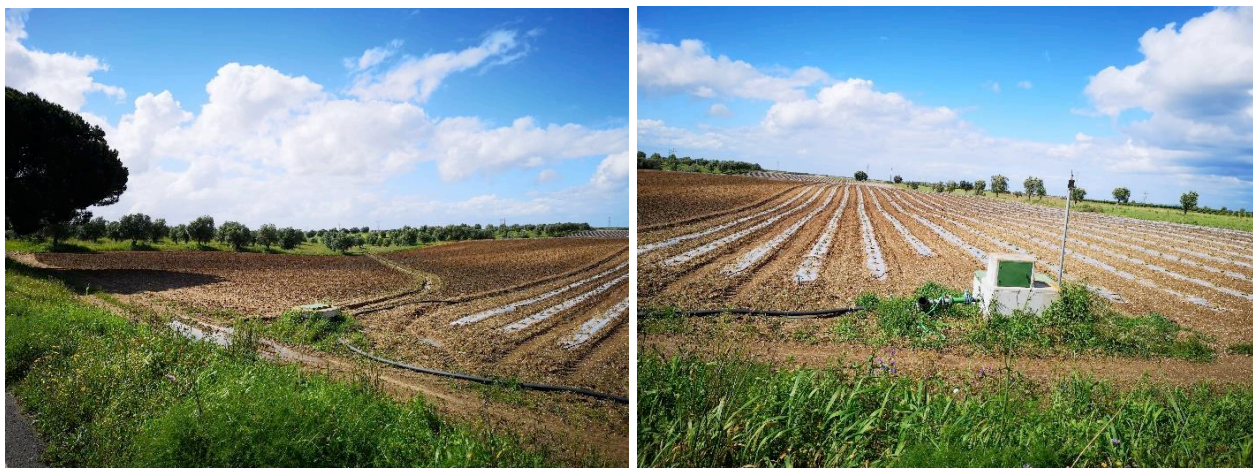
Figure 97 : Ferreira area. Hydrant H17. Photos taken on April 16, 2020 in northwest and north direction.

The hydrant is located in a low point which can lead to water accumulation at this spot, from rain and irrigation water (see the puddle south of the left bloc). The presence of weeds in the interval between the two concrete blocks might indicate the existence of a possible leak but at the same time it is normal to find it here due to the absence of herbicides or soil harrowing.

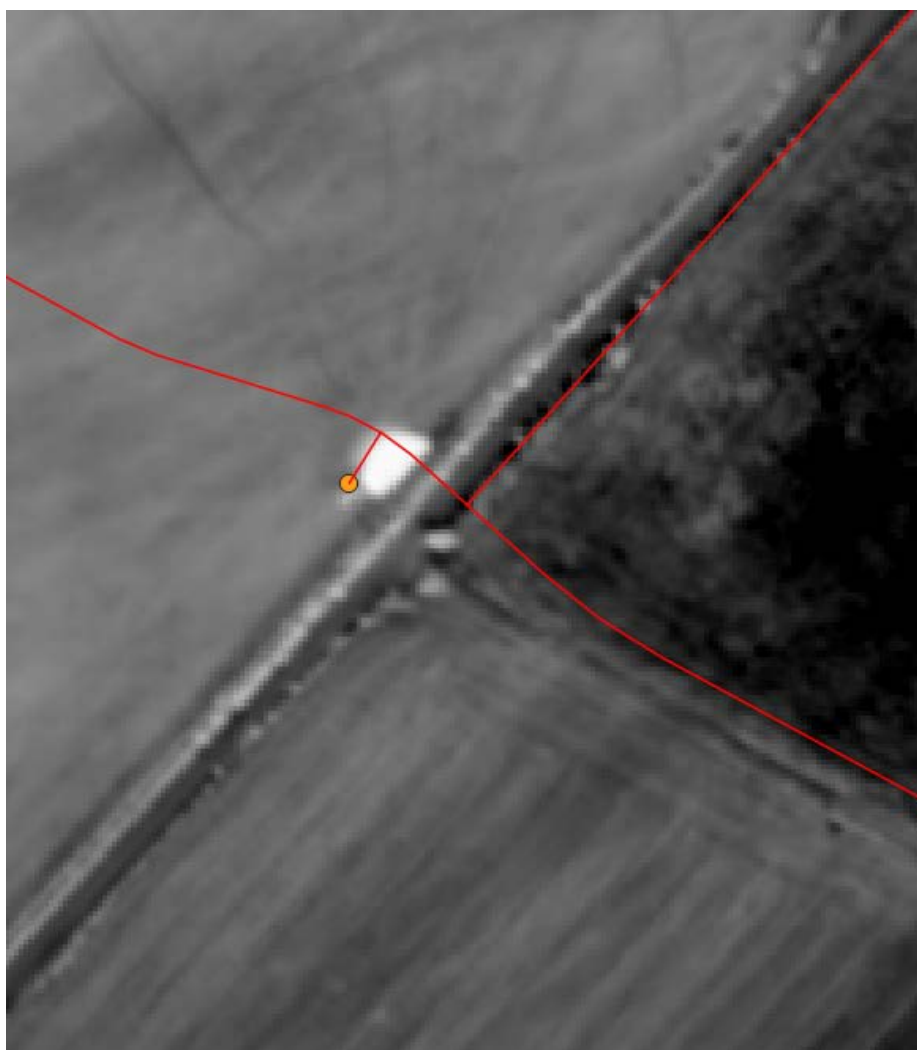
Figure 98 : Ferreira area. Hydrant H12.20.

The water index image shows very high contrast over a large area extending north-east from hydrant H12.20. This anomaly was checked for a potential leak.

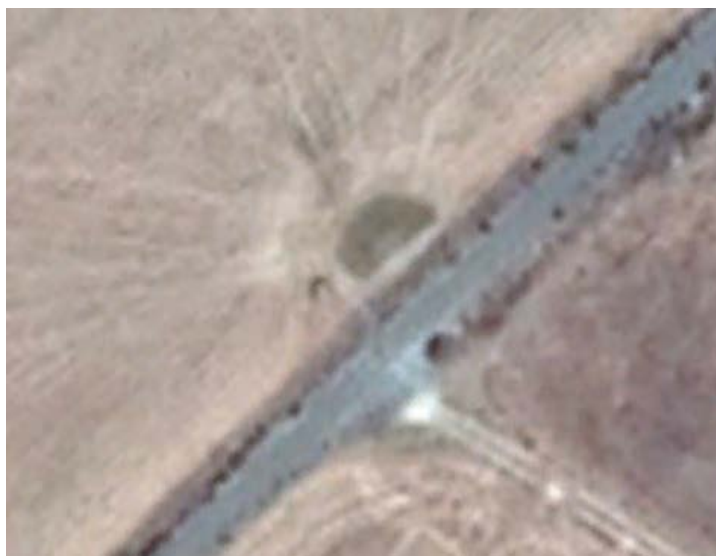
Figure 99 : Ferreira area. Hydrant H12.20. GoogleEarth image from July 16th 2019.

In this summer day, a dark area is seen which is fully correlated with the high water index area in the previous figure, northeast from the hydrant (the dark area could be due to green vegetation or to moist bare soil).

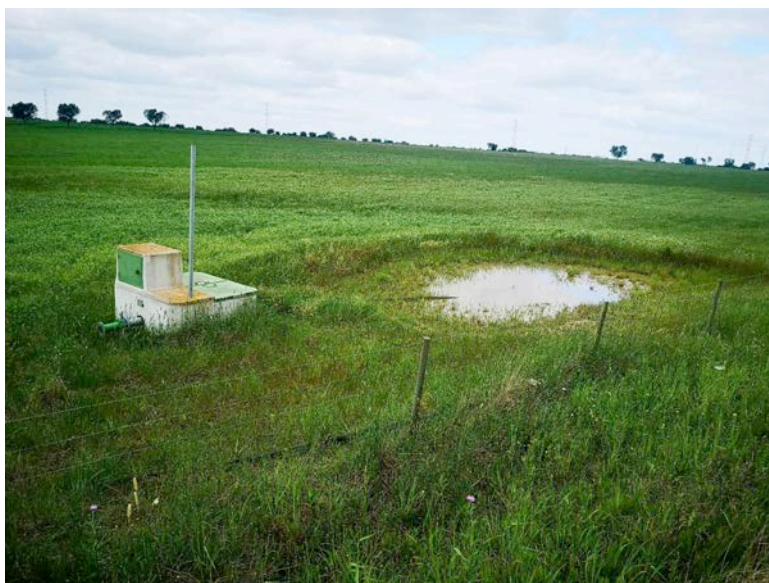
Figure 100 : Ferreira area. Photo of Hydrant H12.20 taken on April 16, 2020 in north direction.

It's very clear that the water accumulation detected is due to a soil depression that keeps water from the area.

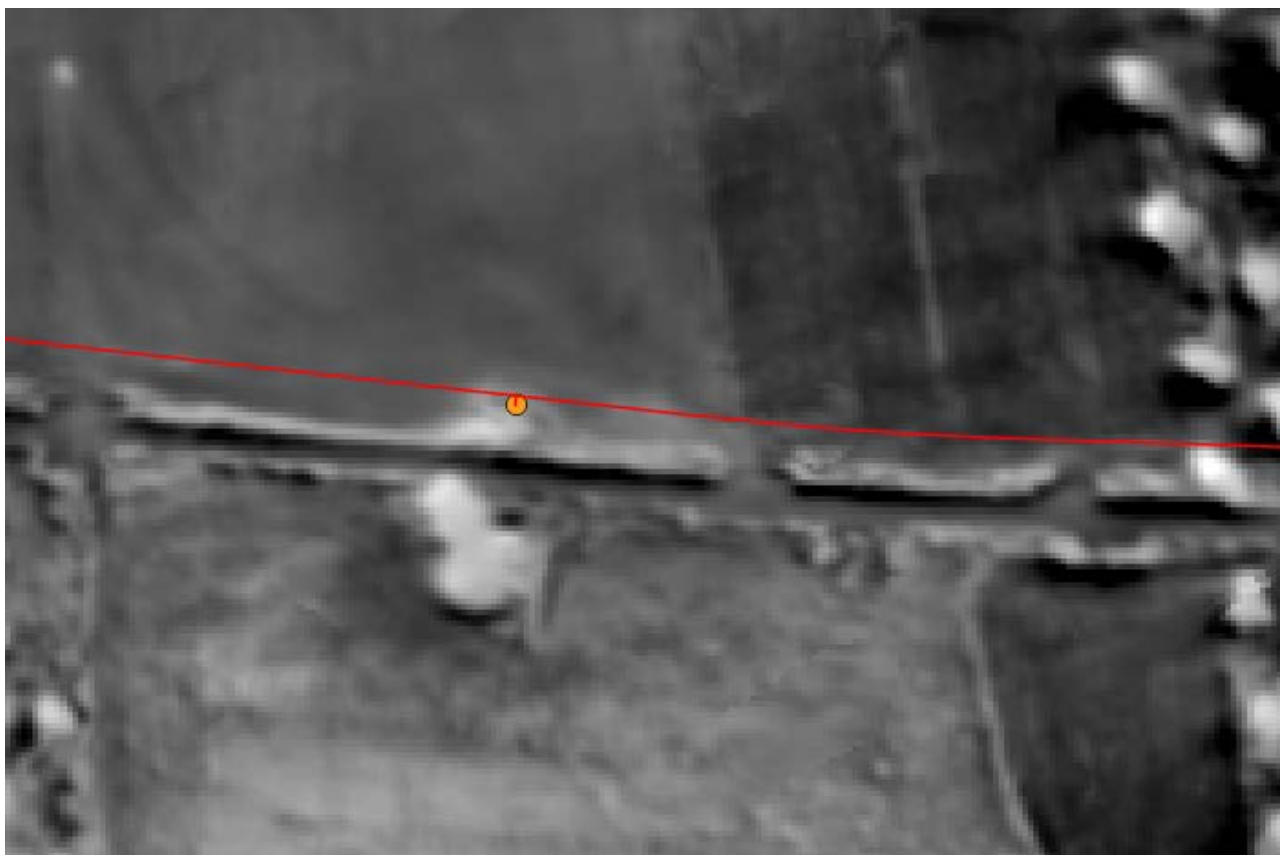
Figure 101 : Ferreira area. Hydrant H15.7.

The water index image shows high contrast over a large area extending south from hydrant H15.7 towards the road. This anomaly should be checked for a potential leak. Remark: the bright area on the other side of the road corresponds to a group of trees and ruins.

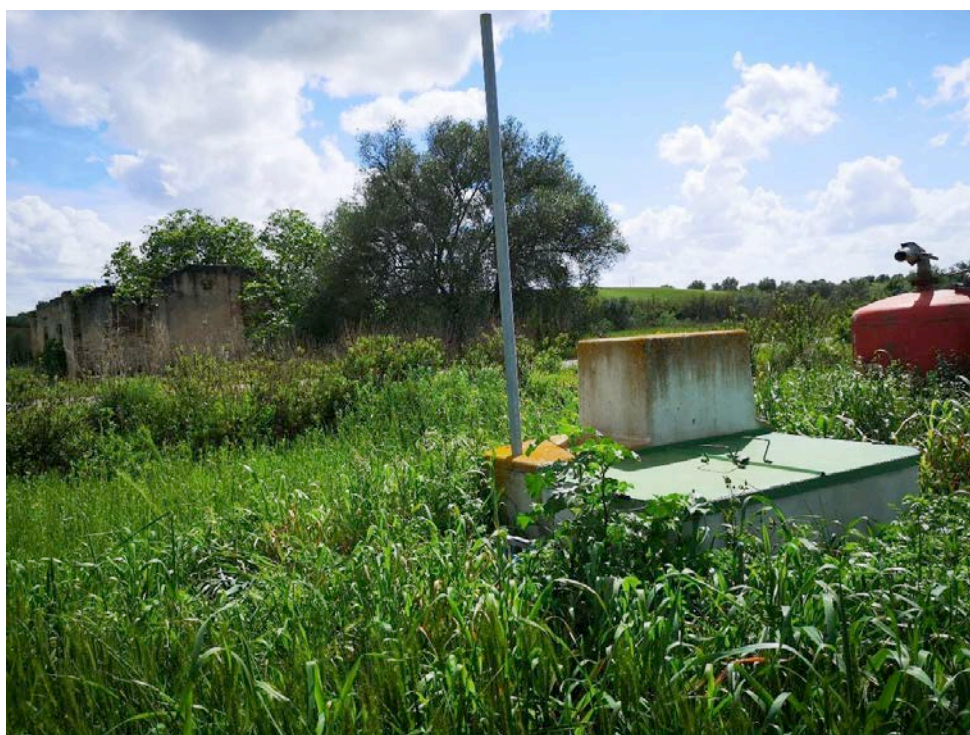
Figure 102 : Ferreira area. Photo of hydrant H15.7

Picture taken on April 16, 2020 in south direction, with trees and an abandoned house on the other side of the road. The hydrant was used for irrigation last campaign. There might be a leak from the connections between the hydrant and the farmer's infrastructure.
