Water-tightness Airborne Detection Implementation

D6.1 - Operational and surveillance demonstrations on water supply and irrigation mains in Portugal - update

Authors: ONERA, GG, AM, SGI, EDIA

31st May, 2020

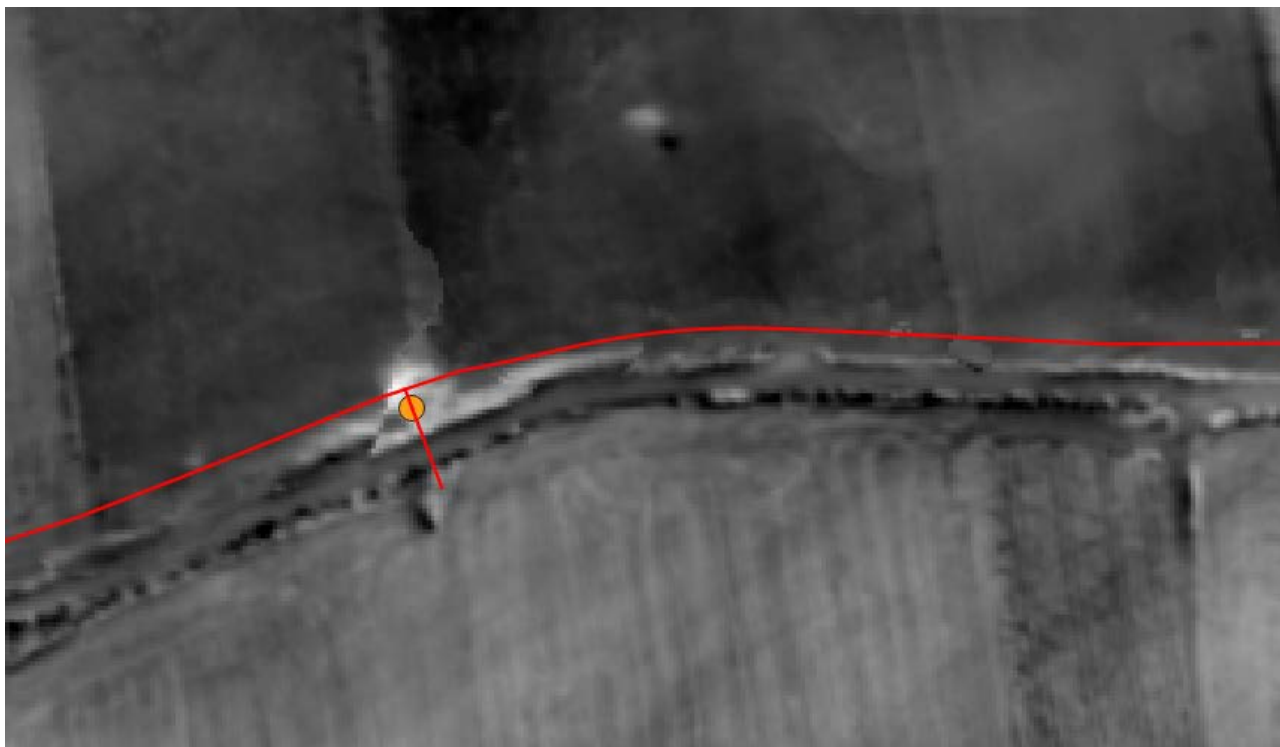
Figure 103 : Ferreira area. Hydrant H15.3.

The water index image shows high contrast over a large area extending north of the hydrant H15.3. This anomaly should be checked for a potential real leak. Remark: the cut running north east and then waving in the north direction is a stitching artifact of the mosaicking process.

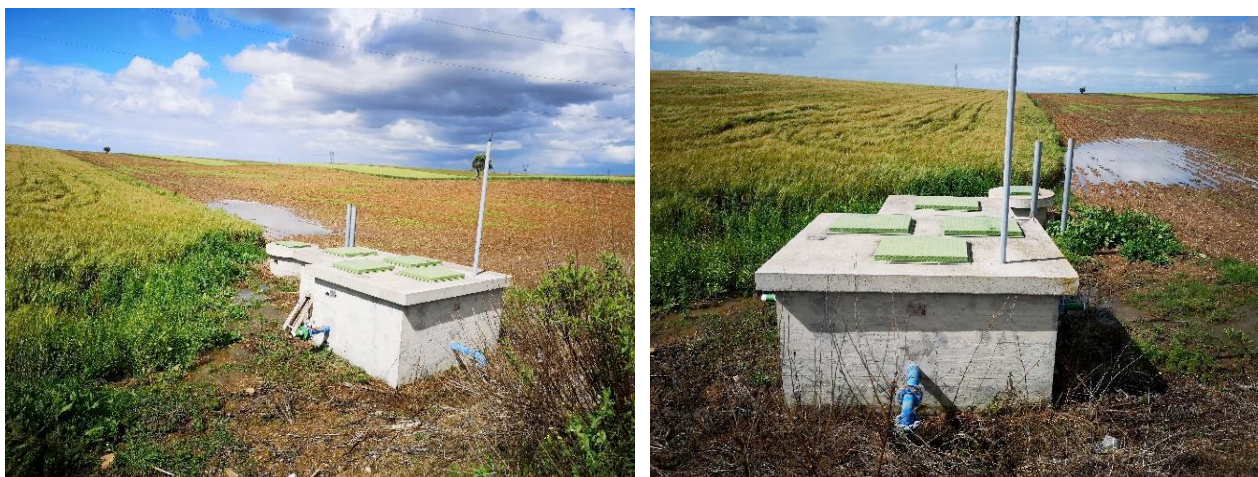
Figure 104 : Ferreira area.

Photos of hydrant H15.3 taken on April 16, 2020 in northeast and north directions. The hydrant was used for irrigation during last campaign. It is located at a low point which can lead to water accumulation at this spot, from rain or irrigation water.

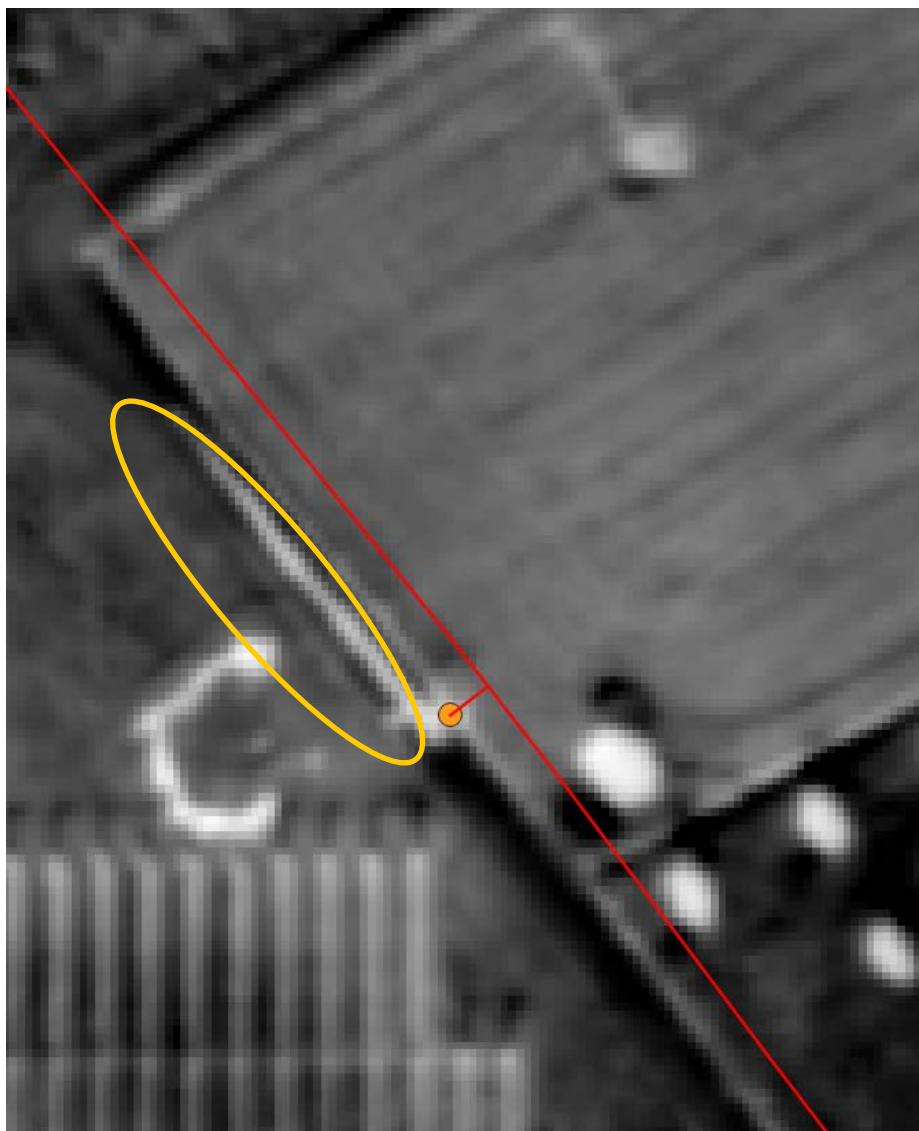
Figure 105 : Ferreira area. Hydrant H10.

The water index image shows high contrast over a stripe running north east from hydrant H10 (see inside the orange ellipse). This anomaly should be checked for a potential leak (unfortunately, on April 16, 2020, there was no access to this area). Remark: the vertical stripes in the bottom left corner of the image correspond to solar panels. The very bright arc north of them is of unknown origin.

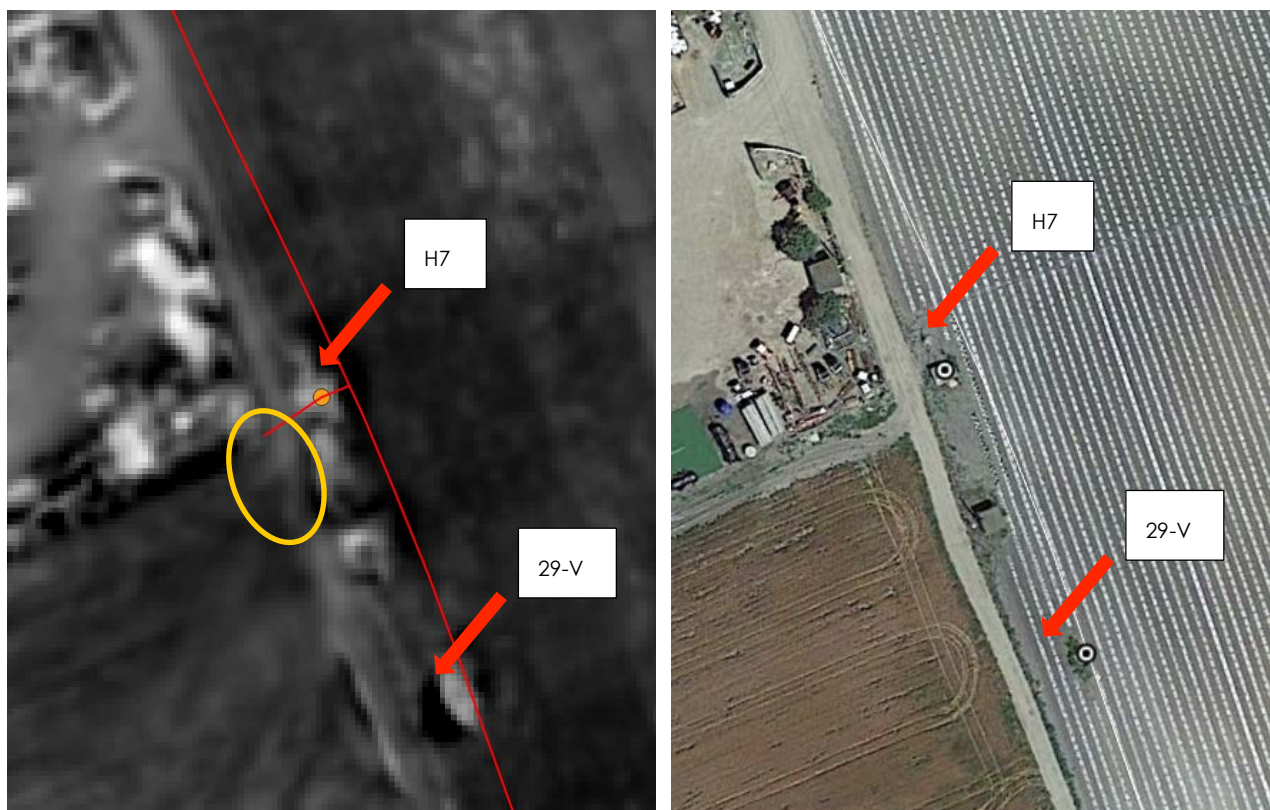
Figure 106 : Ferreira area. Hydrant H7.

The bright spot in the WI image (left) near Valve 29-V is probably due to high vegetation (see GoogleEarth image on right). An elongated area showing high moisture, running south from hydrant H7 (see inside the orange ellipse) is perhaps due to water leak which should be checked.

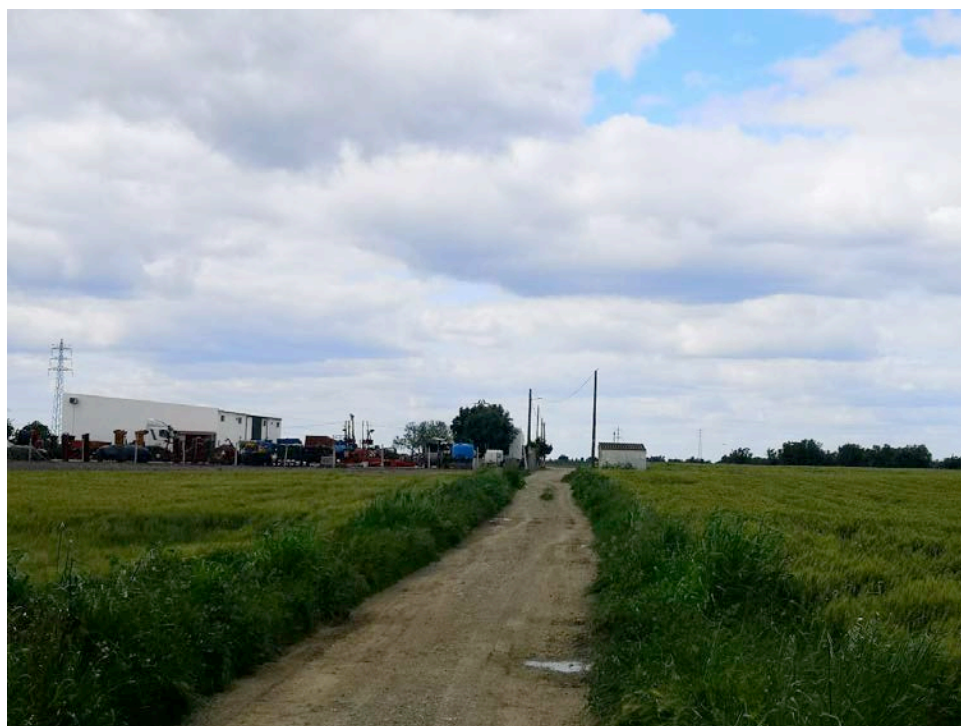
Figure 107 : Ferreira area. Photo of hydrant H7 taken on April 16, 2020 in northwest direction.

The detected possible leak is inside the social area of the farm. It can be related to some material or some natural pond from washing water.

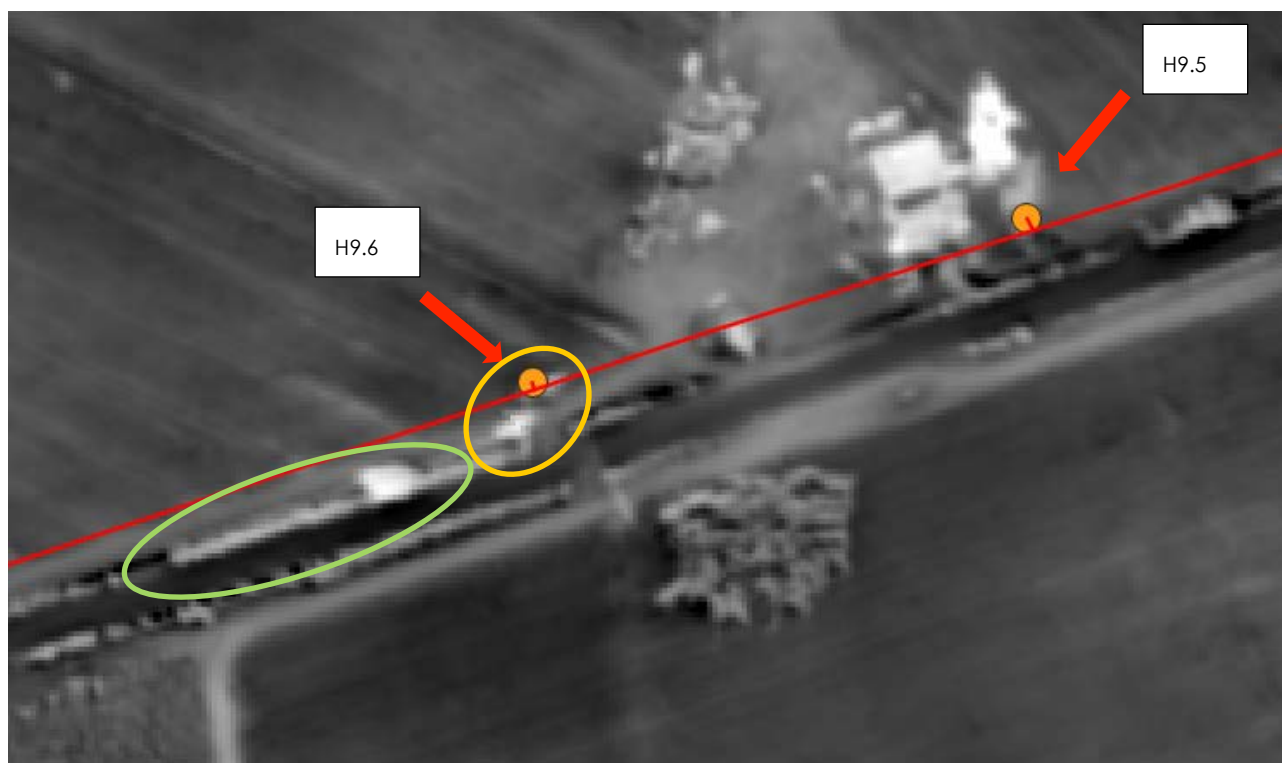
Figure 108 : Ferreira area. Hydrants H9.6 and H9.5.

The water index image shows a few areas with high contrast south west from hydrant H9.6. The one highlighted with an orange ellipse could be attributed to soil moisture and should be checked for a potential leak. The area highlighted with a green ellipse is most probably related to high vegetation (bushes) and shadows.

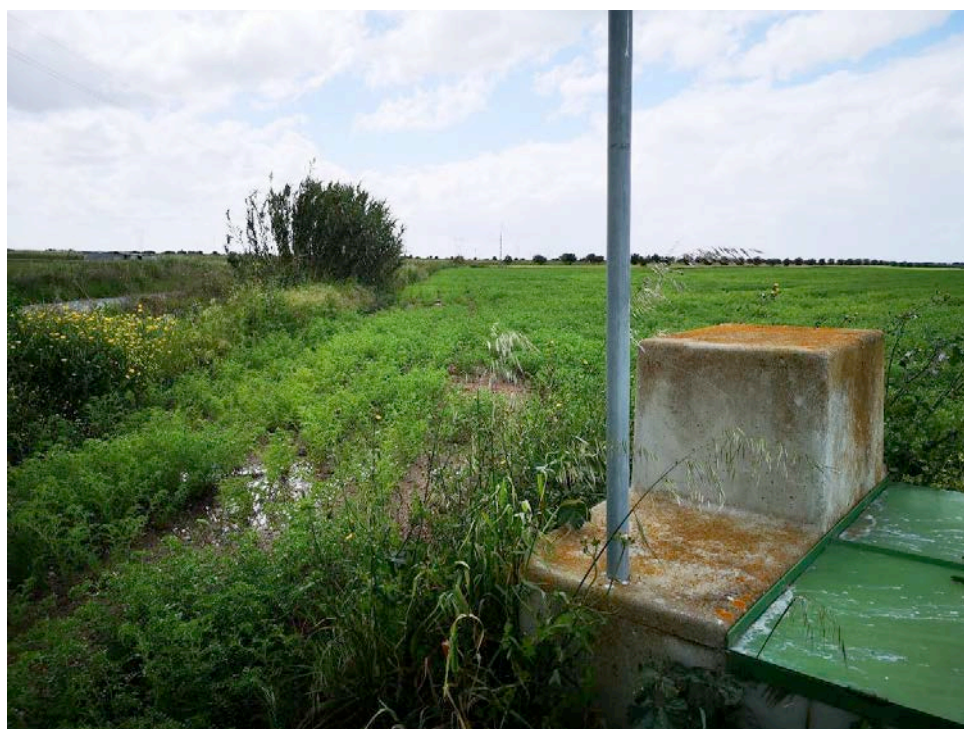
Figure 109 : Ferreira area. Photo of hydrant H9.6 taken on April 16, 2020 in west direction (H9.7 is at background on the top of the picture).

The hydrant was used for the irrigation of melon during last campaign. The presence of canes along the road suggest a permanent source of water at that spot which is almost certainly due to

its low position where water accumulates from the surroundings, from rain or irrigation water (on April 16th, after 30mm of rain during the past 24 hours, a large puddle can be seen between the hydrant and the road).

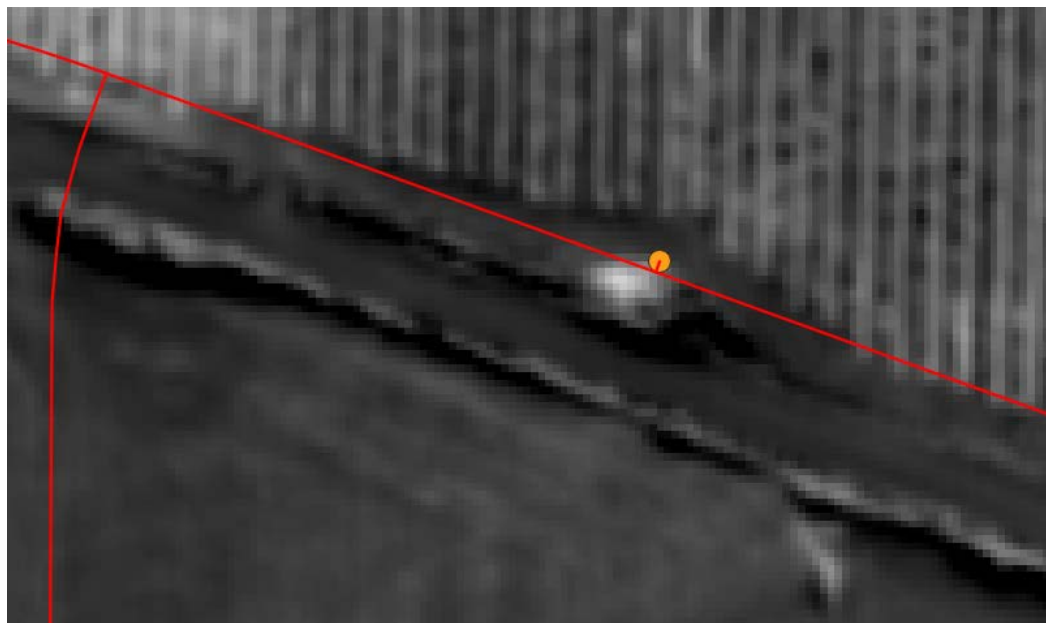
Figure 110 : Ferreira area. Hydrant H9.10.

The water index image shows high contrast over an area spreading south from hydrant H9.10 to the road. This anomaly should be checked for a potential leak.

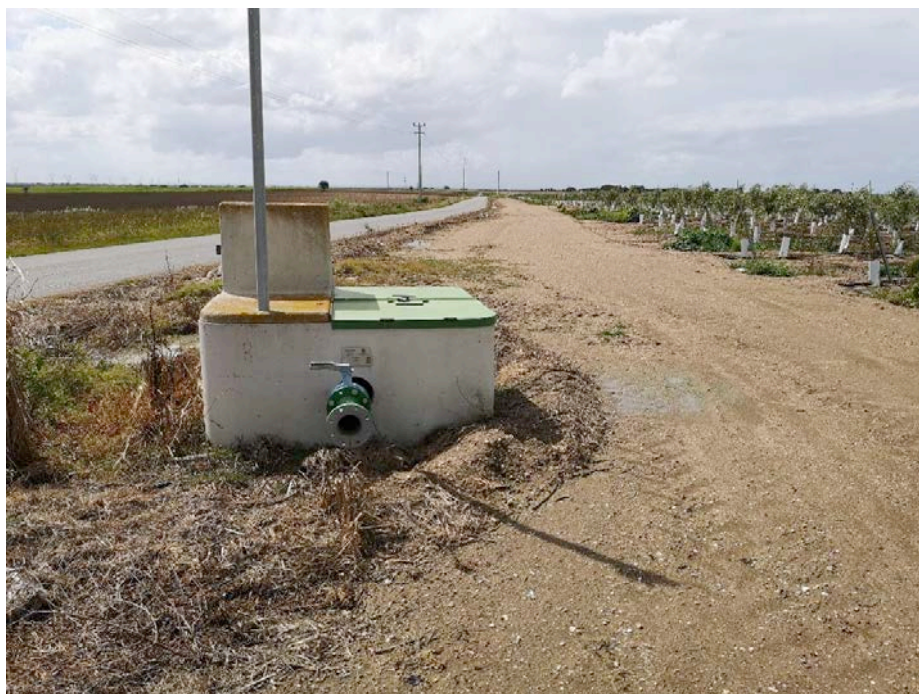
Figure 111 : Ferreira area. Photo of hydrant H9.10 taken on April 16, 2020 in west direction.

The hydrant was not used for irrigation during last campaign.

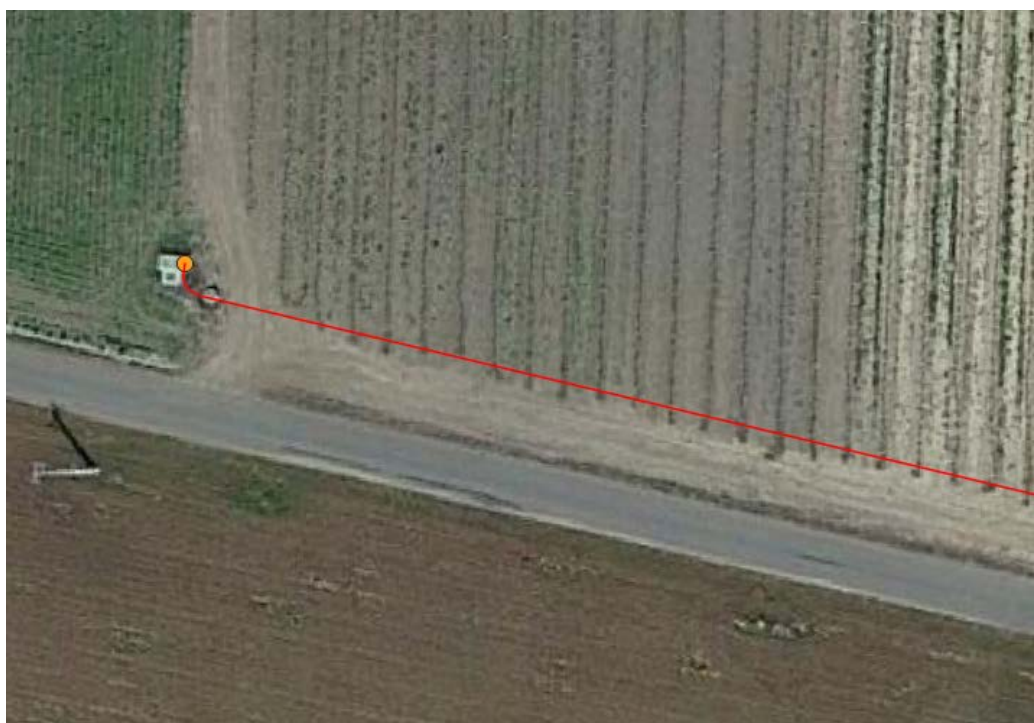
Figure 112 : Ferreira area. Hydrant H9.11.

The water index image (top) shows high contrast over an area spreading south from hydrant H9.11. This anomaly should be checked for a potential leak. There are also two bright spots in the field on the right of H9.10 that are not related to any high vegetation or building in the GoogleEarth image (bottom). The bright spot along the pipeline should be checked for a potential leak.

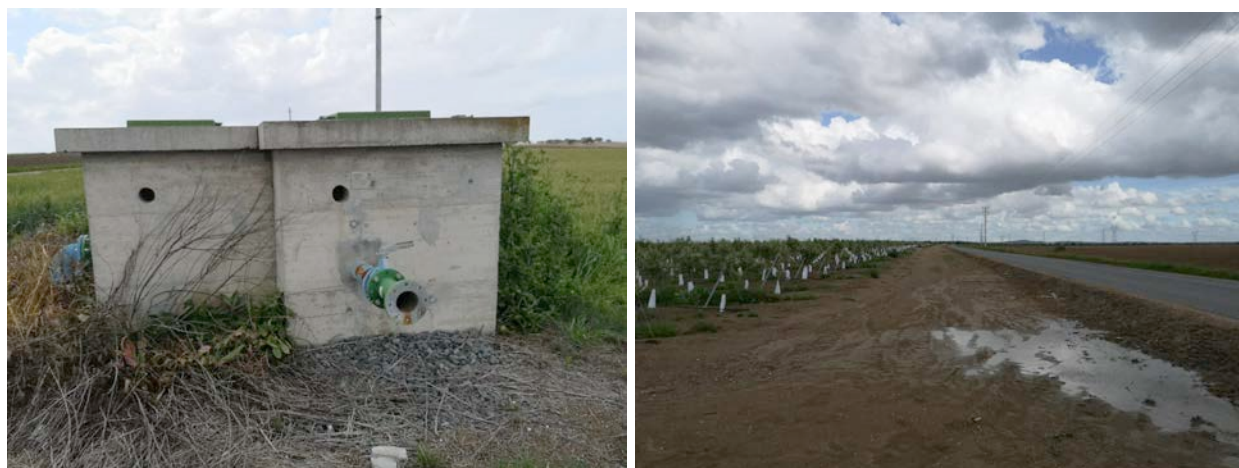
Figure 113 : Ferreira area. Photos of hydrant H9.11 taken on April 16, 2020 in west and east directions. The hydrant was not used for irrigation during last campaign. The right picture shows the drip lines of the olive plantation which always lead to water accumulation in the lower spots.

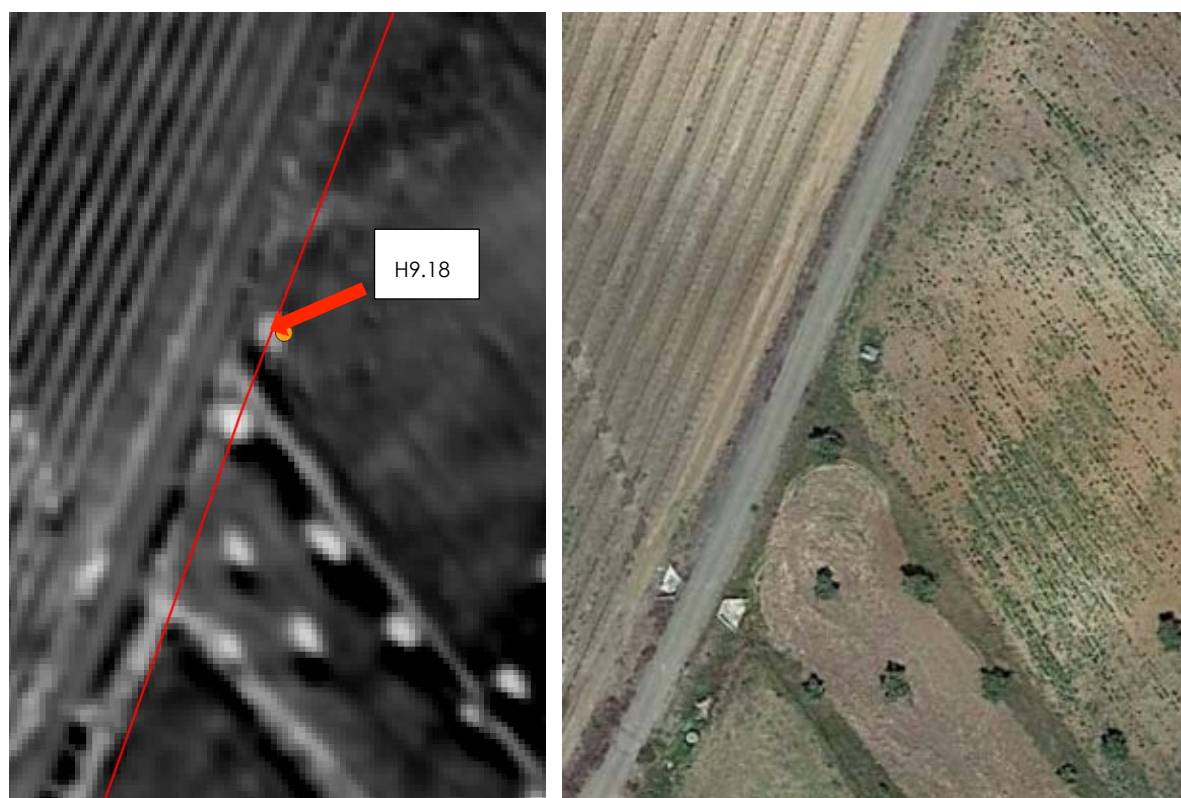
Figure 114 : Ferreira area. Hydrant H9.18.

The water index image (left) shows high contrast near hydrant H9.18. This anomaly should be checked for a potential leak. On right is a GoogleEarth image July 16th, 2019.

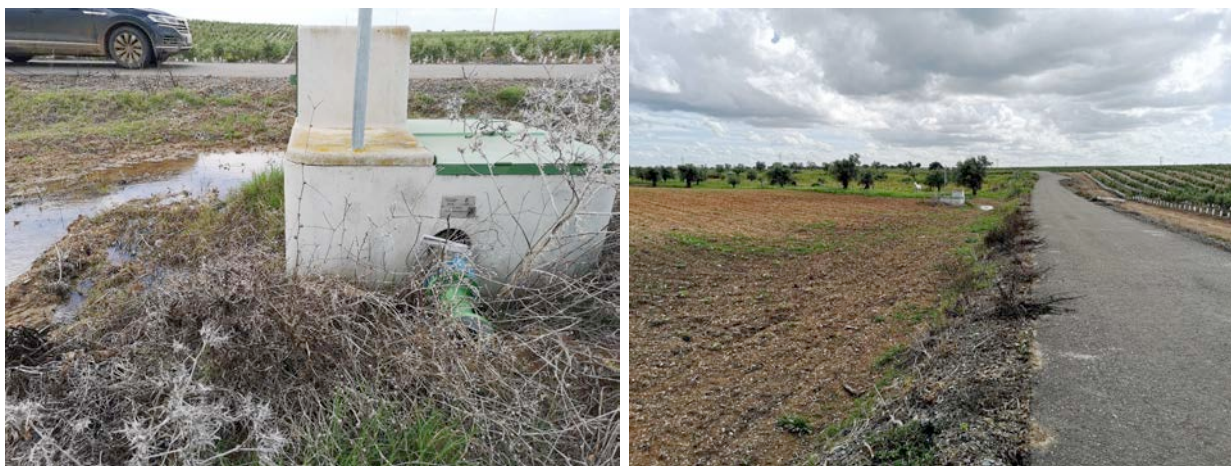
Figure 115 : Ferreira area. Photos of hydrant H9.18 taken on April 16, 2020 in northwest and southwest directions.

The hydrant was used for irrigation during last campaign. There might be a leak from the connections between the hydrant and the farmer's infrastructure. At the same time, the hydrant is located in a low point which can lead to water accumulation at this spot, from rain or irrigation water.

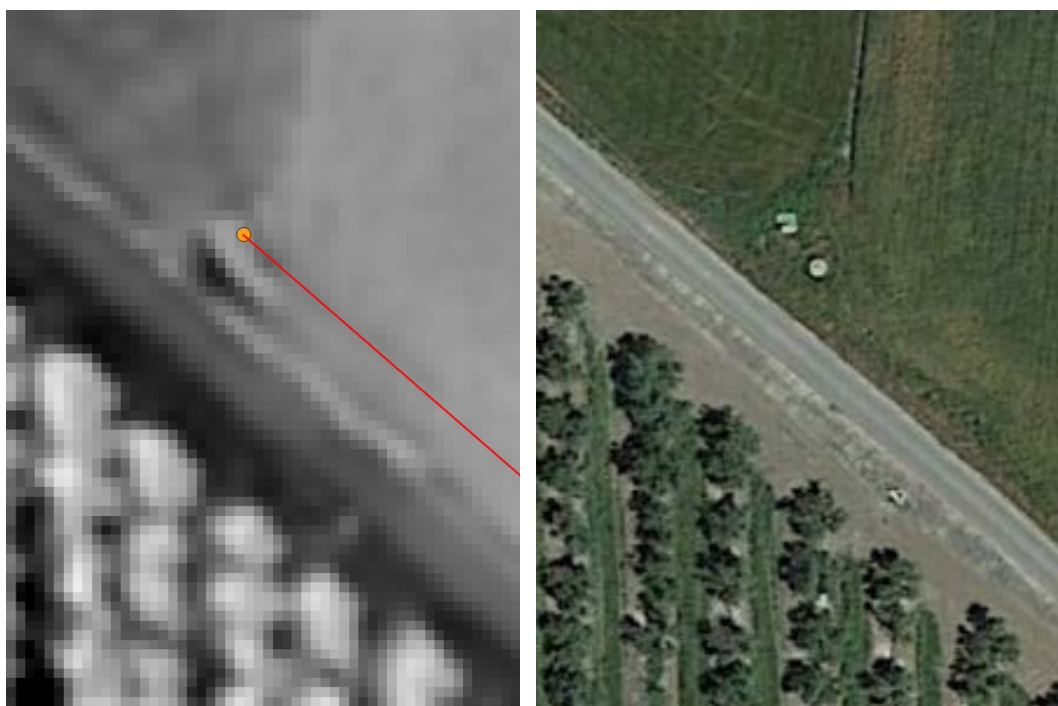
Figure 116 : Ferreira area. Hydrant H17.4.

The water index image (left) shows an anomaly between hydrant H17.4 and the road. This anomaly should be checked for a potential leak.

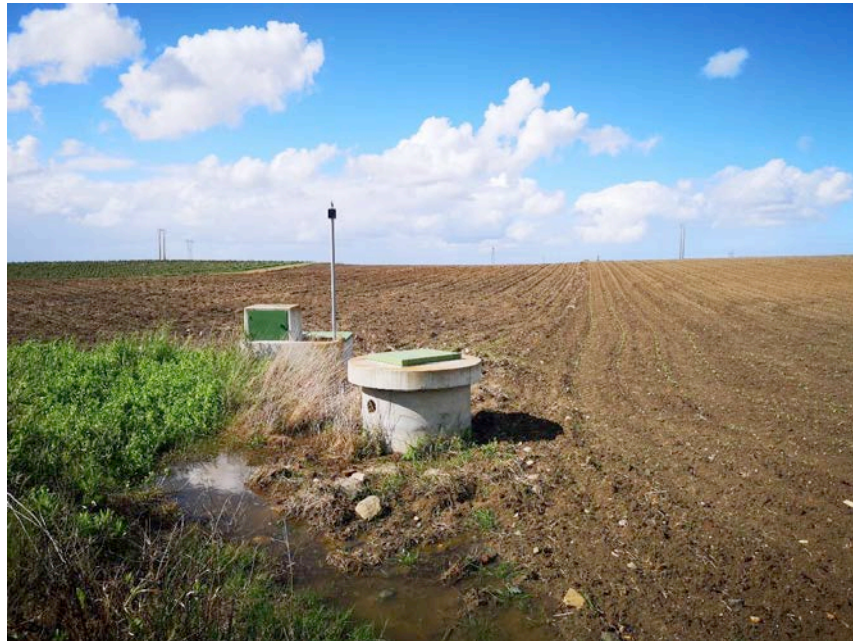
Figure 117 : Ferreira area. Photo of hydrant H17.4 taken on April 16, 2020 in north direction.

Water accumulation close to the hydrant which is located in a low point and right next to the road that acts as a small dam, leading to water accumulation at this spot, from rain or irrigation water.

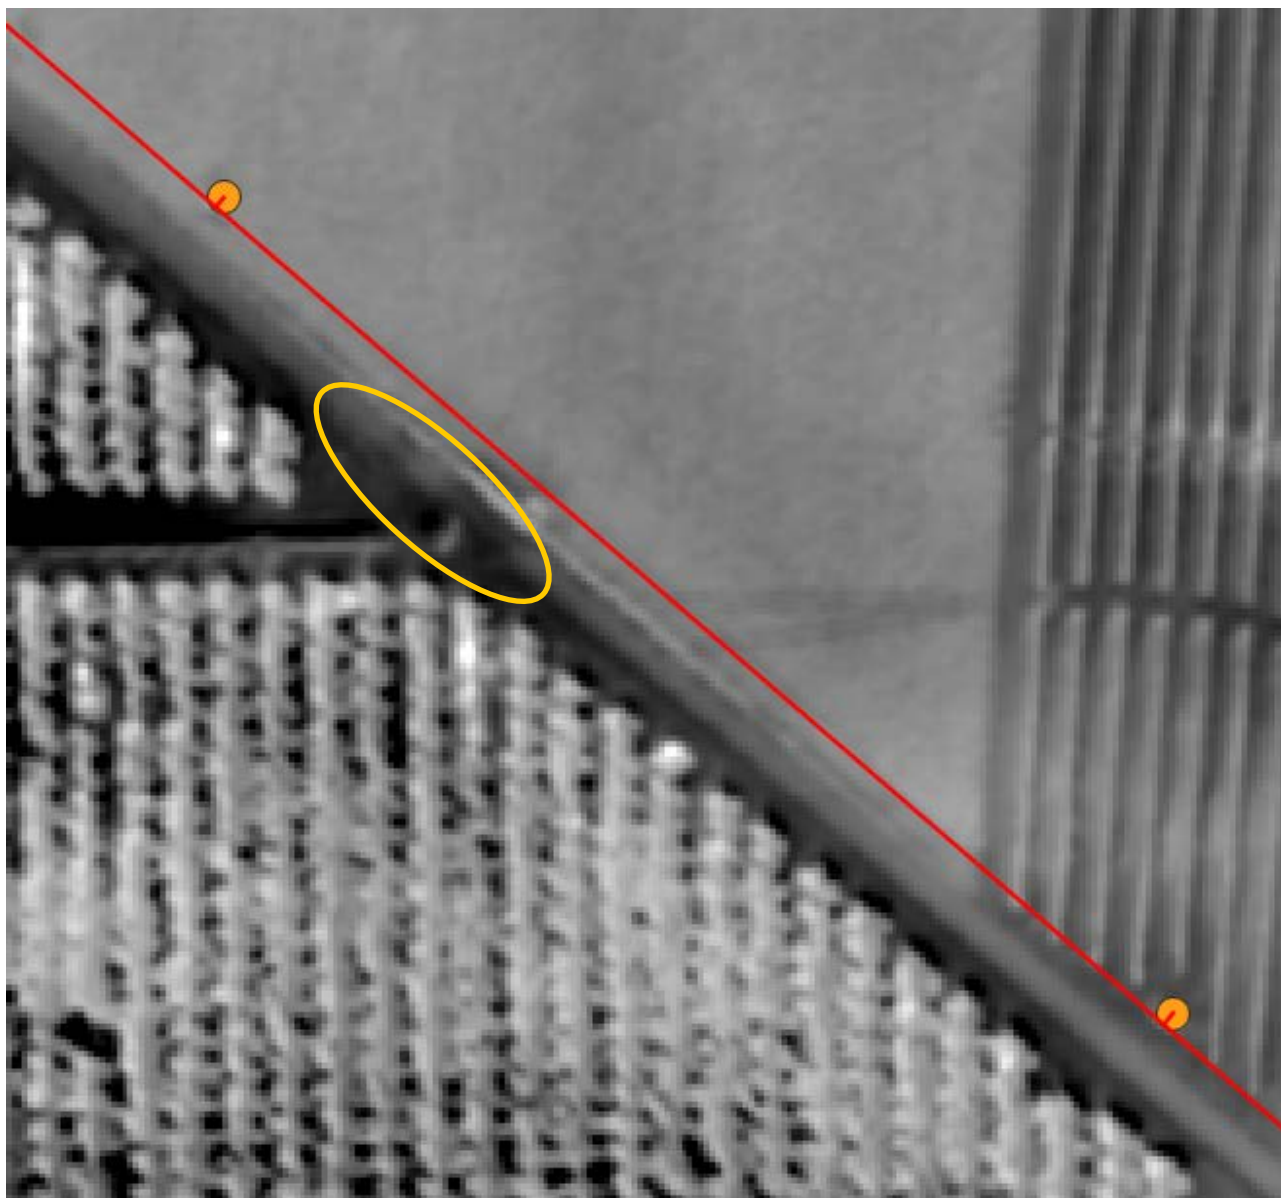
Figure 118 : Ferreira area. Between Hydrant H17.2 (bottom right) and H17.3 (top left).

The water index image shows an anomaly between these two hydrants at the location of valve 17.4-DF (see inside the orange ellipse). This anomaly should be checked for a potential leak.

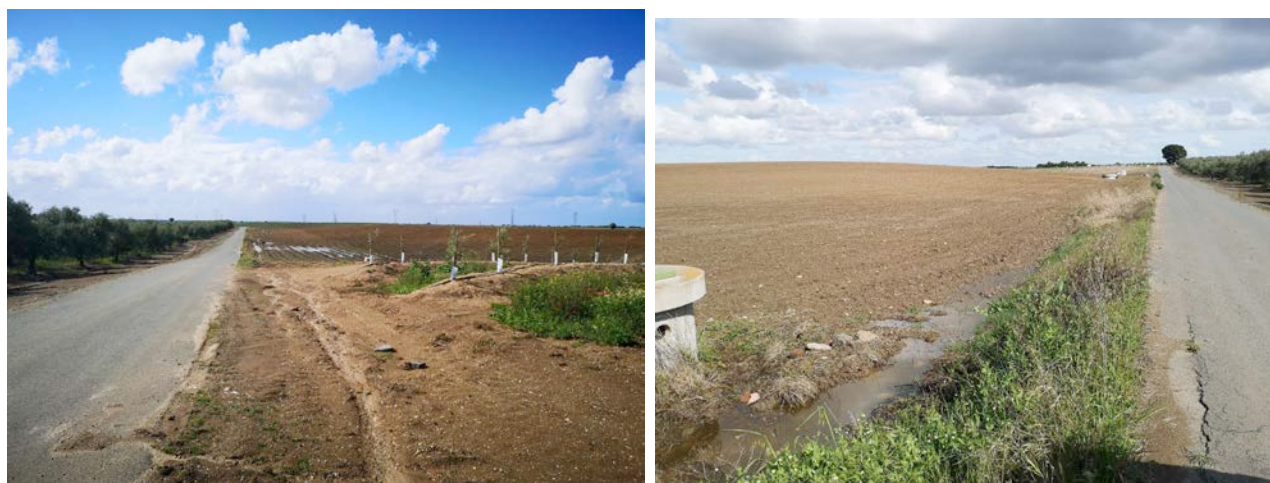
Figure 119 : Ferreira area. Left: side road along C17 pipe in northwest direction.

In this image we can see water accumulation close to the 17.4DF (discharge valve) near to H17.2. This specific area is located in a low point which can lead to water accumulation at this

spot, from rain or irrigation water. Right: same in in southeast direction where we can see H17.4, H17.3 and H17.2.

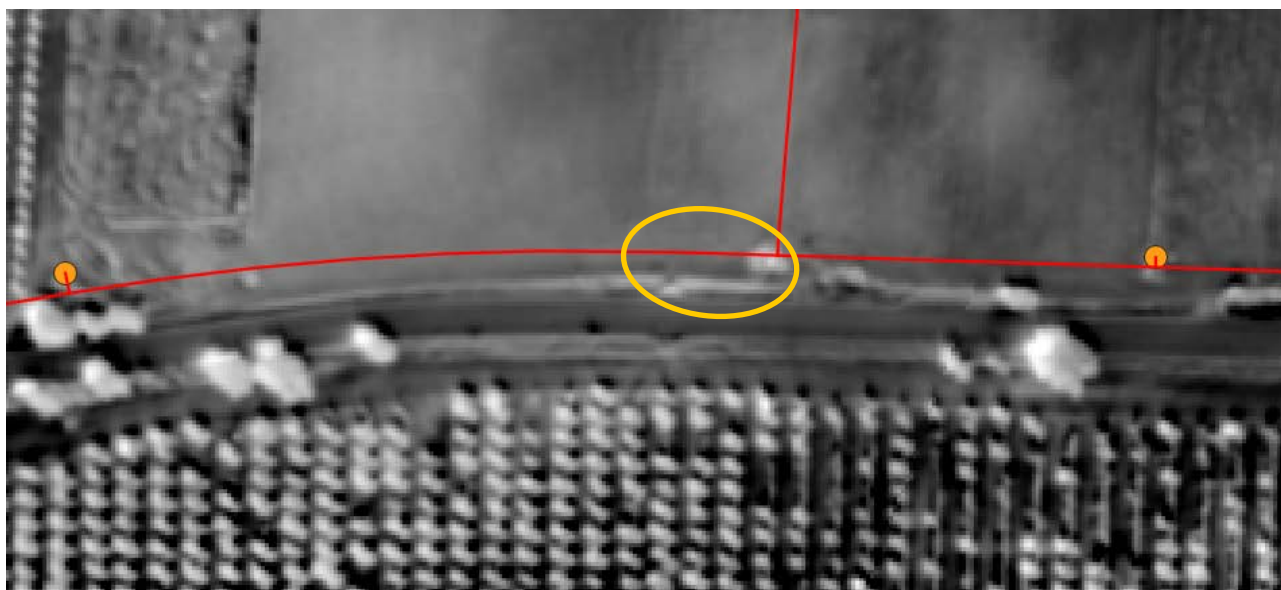
Figure 120 : Ferreira area. Between Hydrant H21 (right) and H22 (left).

The water index image shows an anomaly between these two hydrants at the location of valve 66-V (see inside the orange ellipse). This anomaly should be checked for a potential leak.

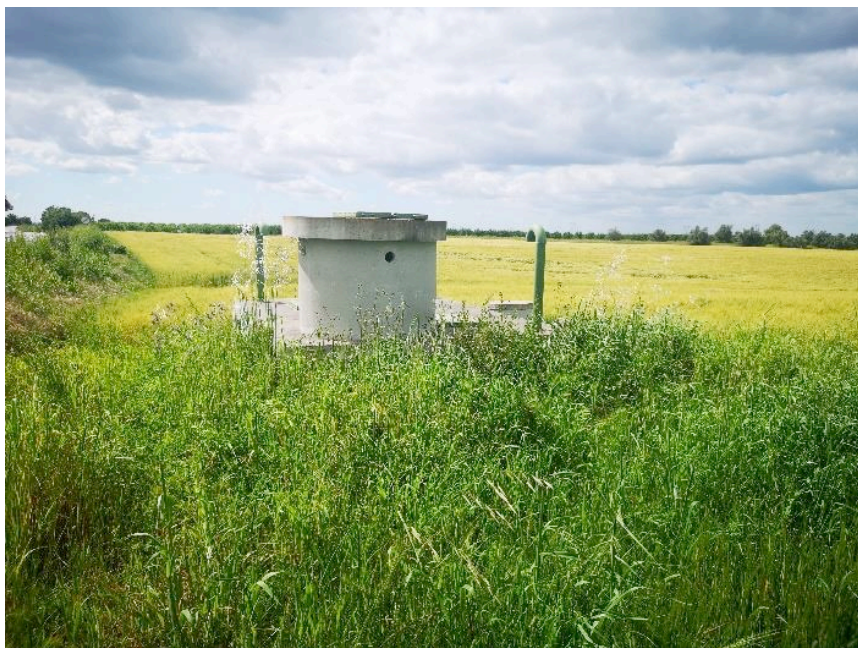
Figure 121 : Ferreira area. Photo taken on April 16, 2020 between H21 and H22 in west direction. No water seems present, yet high vegetation can be seen.

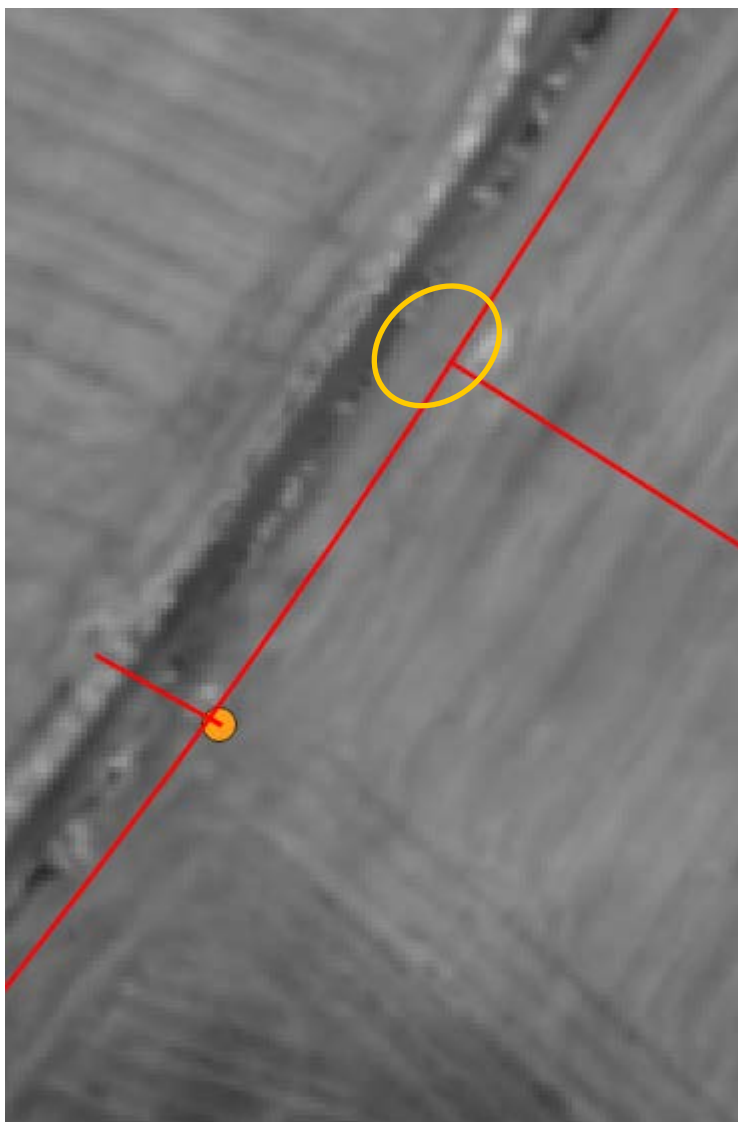
Figure 122 : Ferreira area. Hydrant H12.12.

The water index image shows an anomaly close to the junction north of H12.12, where is located the valve 12.5-VS (see inside the orange ellipse). This anomaly should be checked for a potential leak.

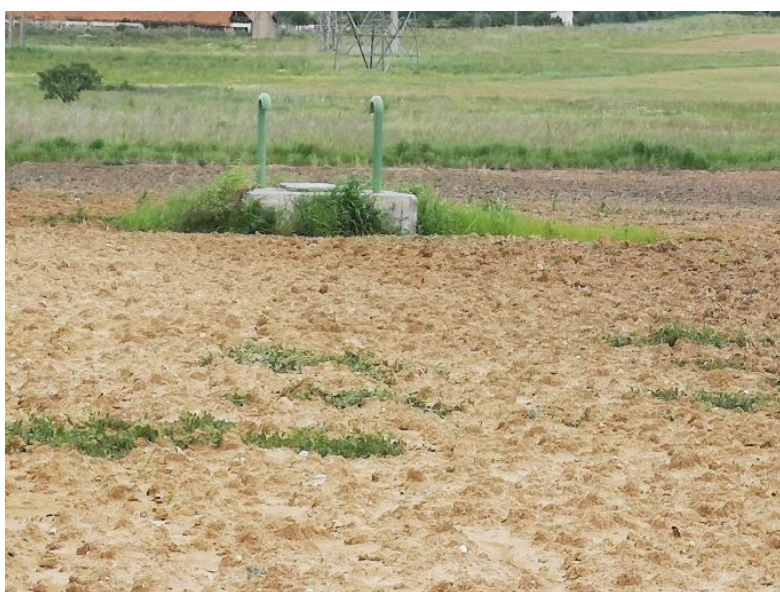
Figure 123 : Ferreira area. Photo taken on April 16, 2020 of the junction 12.5-VS

This area is located at a low point which can lead to water accumulation, from rain or irrigation water.

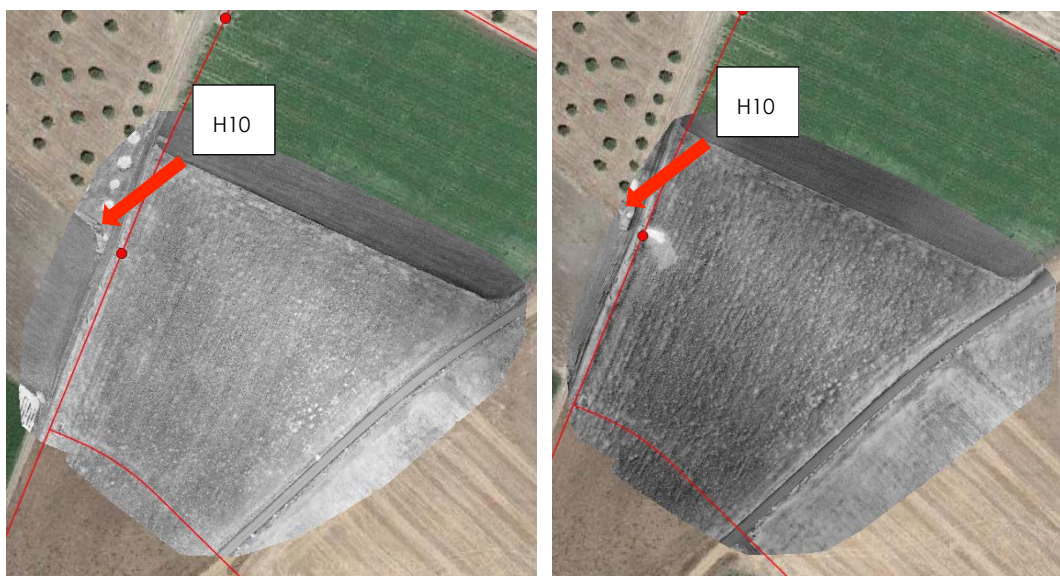
Figure 126 : Artificial leak H10 (left: 14-05-2019: 14:07– and after the vane was opened – right: 16-05-2019: 14:36).

Map of water index as inferred from TIR and OSAVI images. The presence of moisture is mostly seen in the TIR image. Two moist areas can be observed: one of small extend, oriented east presenting a high contrast (this is the result of the leak performed on the same day), and another one, of larger extent, oriented south-east, with a lower contrast which encompasses the former (this is the result of the leak performed two days before)

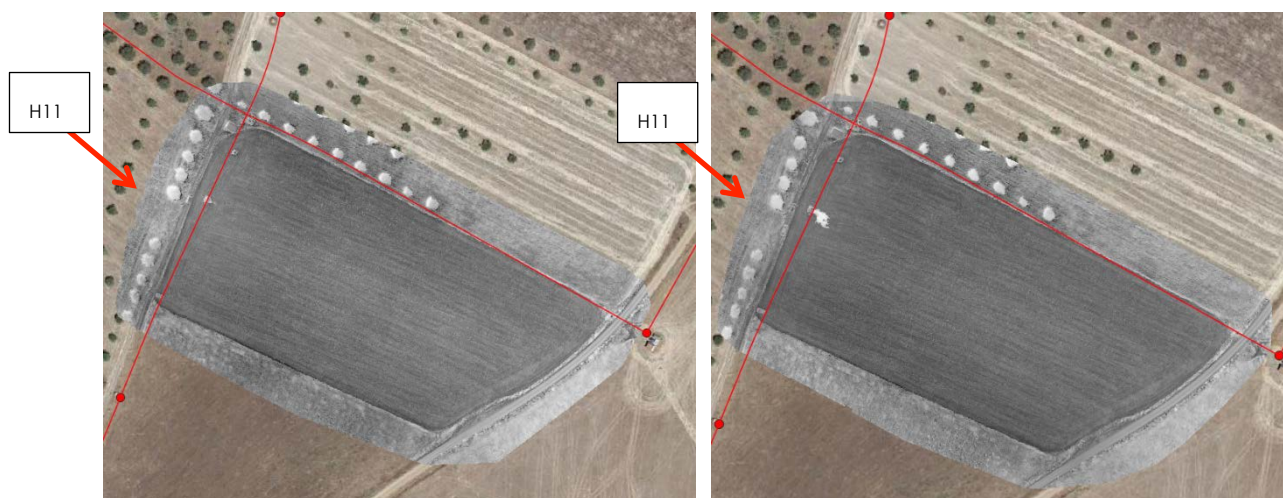
Figure 128 : Artificial leak H11 (water leak on 14-05-2019, the same day as the UAV flight). Left : before, right: after the water leak

Map of water index as inferred from TIR and OSAVI images. The contrast between wet soil and dry soil is very high. The presence of moisture is seen in both OSAVI and TIR images but with a higher contrast in the TIR image.

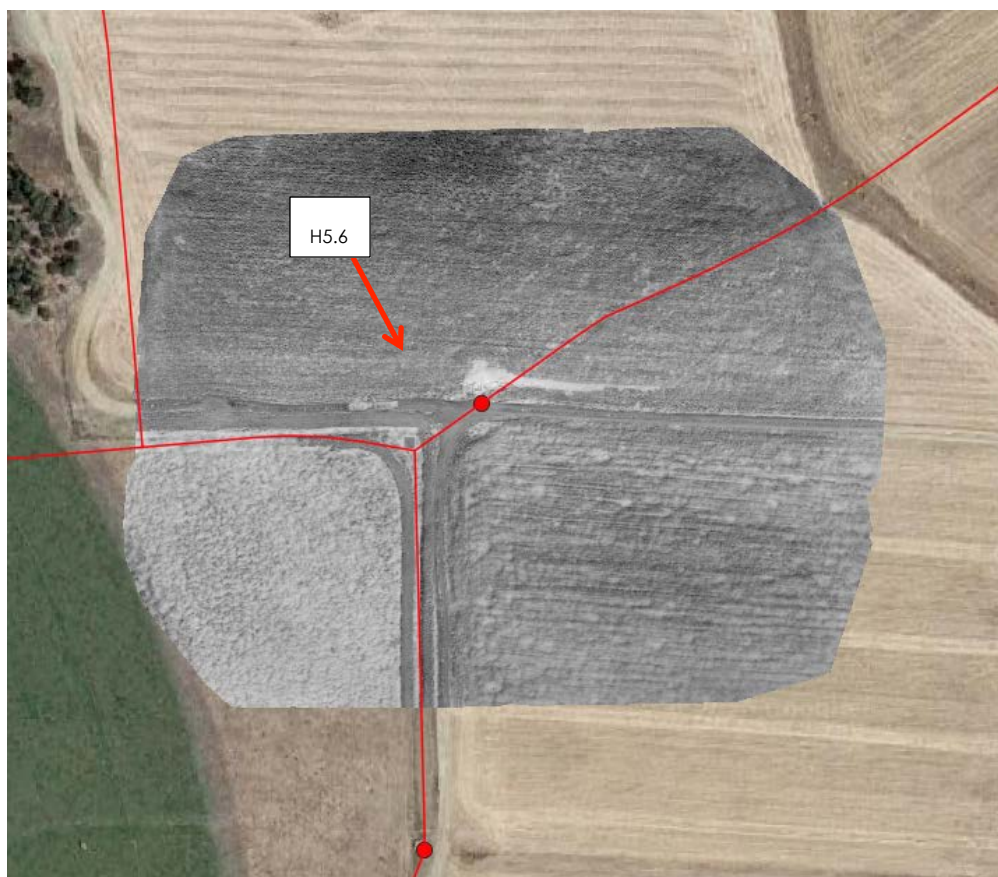
Figure 129 : Artificial leak H5.6 (16-05-2019 - 16:19)

Map of water index as inferred from TIR and OSAVI images. The presence of moisture is mostly seen in the TIR image.

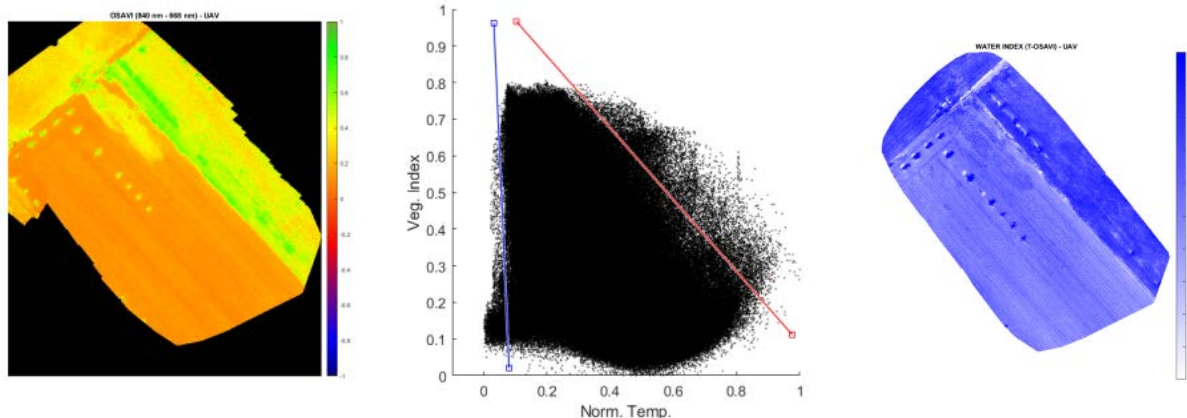
A ground truth measurement, carried out simultaneously, has shown that the mean moisture level was about 13% along the leak area while reaching locally 23%, whereas it was only about 7% a few meters aside. Sparse green vegetation (short grass) could be seen along the leak area, as opposed to dry vegetation away from it.

Figure 131 : OSAVI vegetation index map (left), triangle scatterplot (middle) and WI map (right) obtained with the UAV. Sept 10

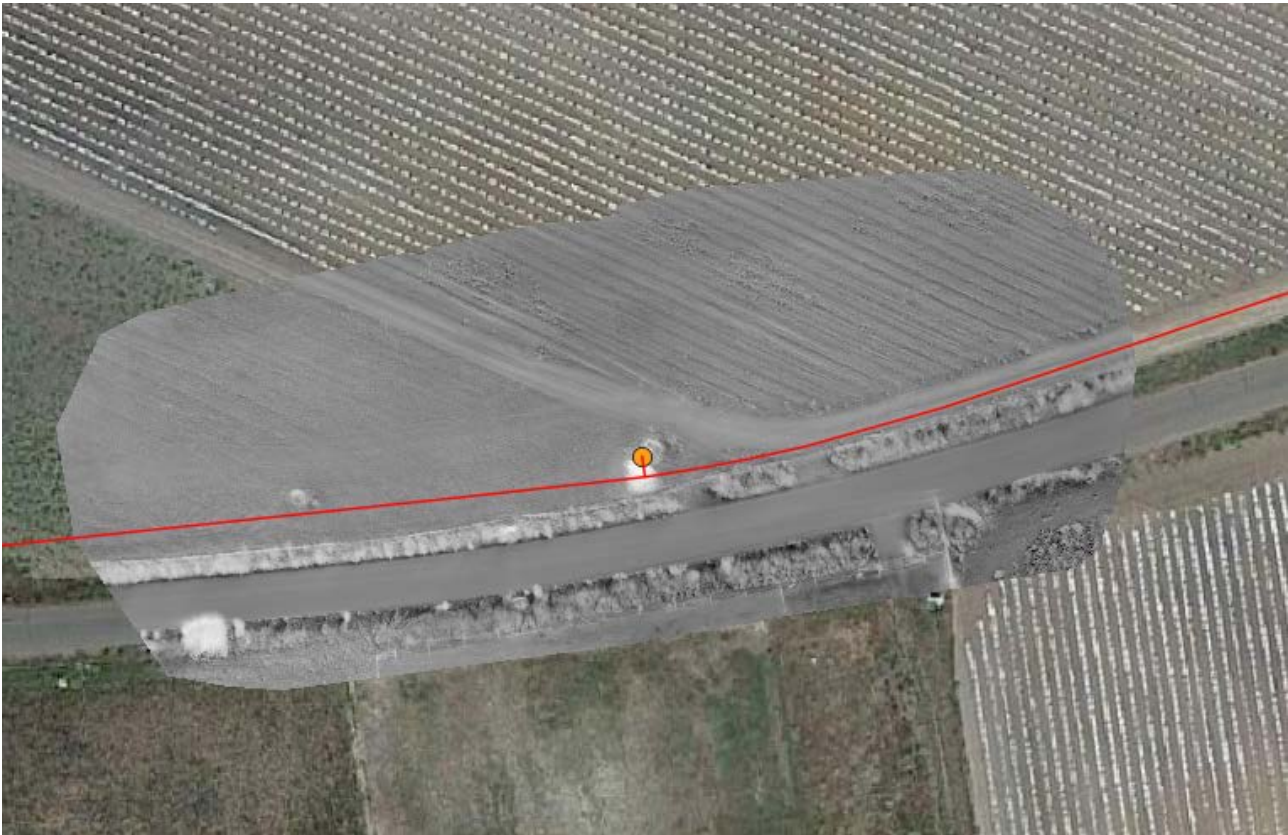
Figure 138 : Ferreira area. Artificial "leak" H9.7, Sept 12.

The results for the water index are reported in the two following images. In both case, a significant contrast was observed in the close vicinity of the hydrants that revealed the excess of water in the soil.

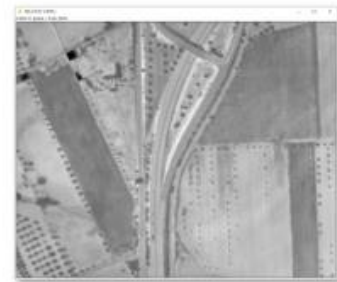
506_TIR.PNG

Real Leak => B4-B7 n°254 / TIR 506

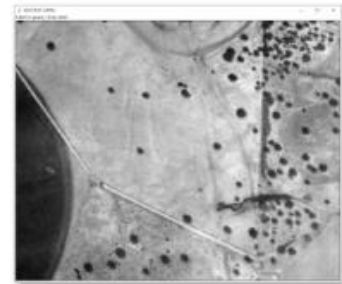
929_TIR.PNG

Real Leak 1 => B4-B7 n°465 / TIR 929

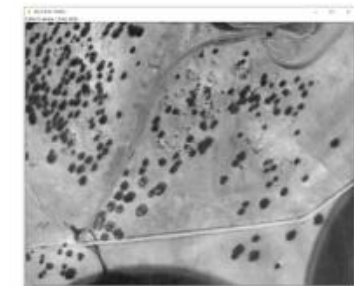
202_TIR.PNG

Real Leak 2 => B4-B7 n°98 / TIR 202

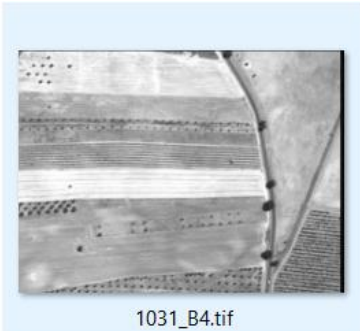
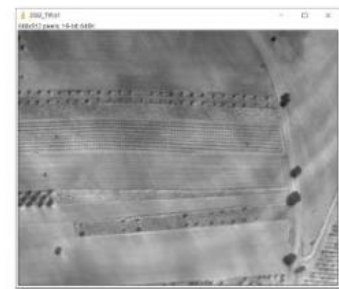
Artificial Leak 1 => B4-B7 n° 1031 / TIR 2062

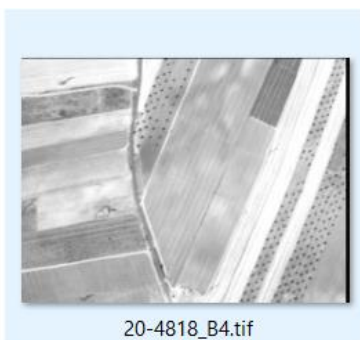
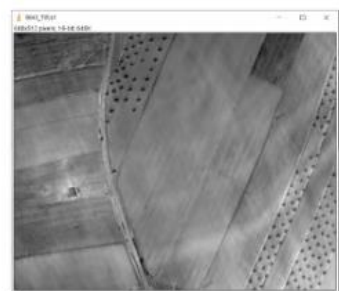
Artificial Leak 2 => B4-B7 n° 4818 / TIR 9643

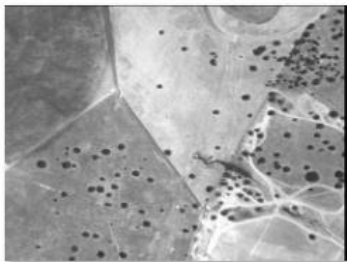
10-620_B4.tif

Real Leak 1 => B4-B7 n°620 / TIR 1237

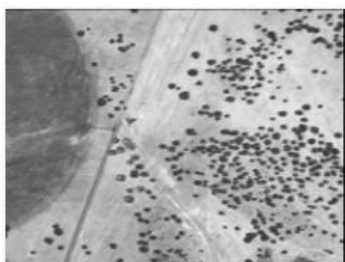
20-652_B4.tif

Real Leak 2 => B4-B7 n°652 / TIR 1305
