Water-tightness Airborne Detection Implementation

D6.1 - Operational and surveillance demonstrations on water supply and irrigation mains in Portugal - update

Authors: ONERA, GG, AM, SGI, EDIA

31st May, 2020

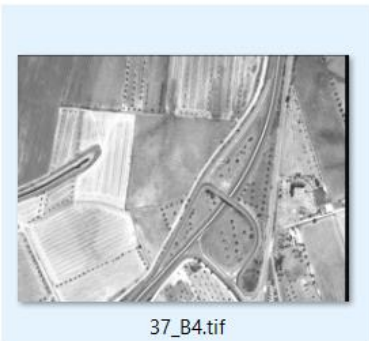
37_B4.tif

Real Leak => B4-B7 n°37 / TIR 77
